Bulletin No.: 14728B

SUBJECT: Special Coverage Adjustment – Cracked Fuel Tank Inlet Control Valve

MODELS: 2006-2008 Chevrolet Cobalt

2006 Pontiac Pursuit, G4 2007-2008 Pontiac G5 2006-2007 Saturn ION

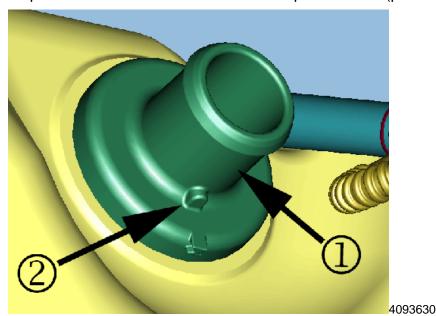
Identifying the 20870462 or 25947828 fuel tank.

The fuel tank hose connection (1) will have an index feature (2) at the bottom 6 o'clock position where the hose joins the tank. Older style tanks have this feature on top at the 12 o'clock position. The fuel tank may also have an identifying tag displaying the part number.

- If the part number *is* 20870462 or 25947828, and has the bottom index, stop, this bulletin does not apply.
- If the part number *is not* 20870462 or 25947828, and has the top index, proceed to Steps 3 and 4.
- 3. Replace the fuel tank with p/n 20870462 or 25947828 as applicable. Refer to *Fuel Tank Replacement in SI*.
- 4. Replace the filler pipe.
 - a. **Cobalt, G4, G5, Pursuit ONLY**: Use p/n 20757861 fill pipe assembly. Refer to *Filler Tube Replacement in SI*.
 - b. ION ONLY: Trim new hose p/n 20757866 to match existing fuel fill hose.
 - 1. Remove fuel fill hose from vehicle mounted fill pipe.
