# Service Bulletin

**SUBJECT:** Special Coverage Adjustment – Diesel Fuel Odor

**MODELS:** 2010-2015 Chevrolet Express  
2011-2015 Chevrolet Silverado HD  
2010-2015 GMC Savana  
2011-2015 GMC Sierra HD  
Equipped with 6.6L Duramax Diesel Engine (RPO LML or LGH)

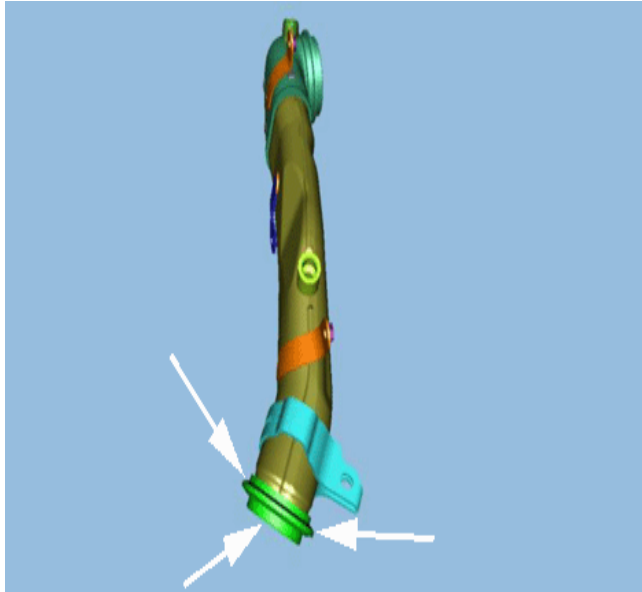
**Note:** The illustration above is the updated turbocharger exhaust pipe with a pilot flange.

- If the concern is NOT present, no further action is required
- If the concern IS still present, the turbocharger exhaust pipe may need to be replaced on trucks built prior to the breakpoints listed below with an updated turbocharger exhaust pipe with a pilot flange. If the turbocharger exhaust pipe on the customer's vehicle has the new flange, you should not need to replace it. Refer to *Turbocharger Exhaust Pipe Replacement* in SI.

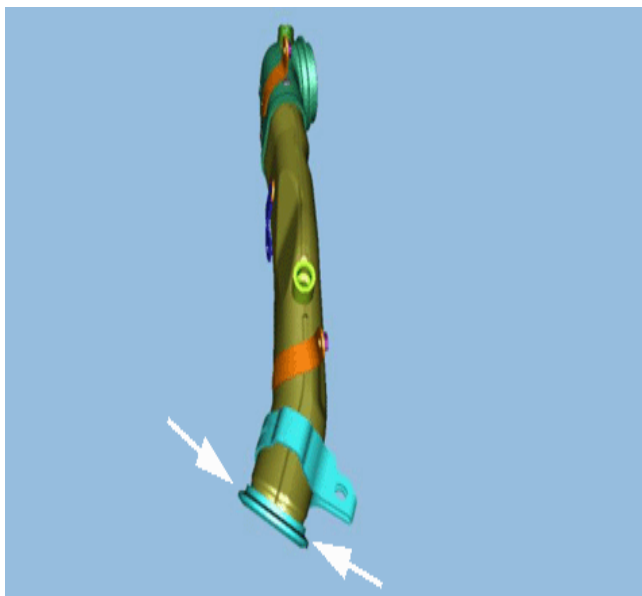
**Note:** The illustration above is the turbocharger exhaust pipe without a pilot flange.

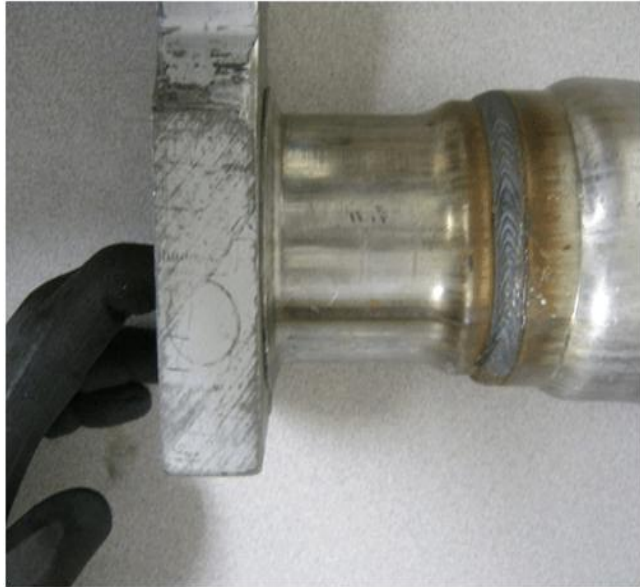
2748856

**Note:** In most cases it will not be necessary to replace the exhaust downpipe/catalytic converter assembly for this condition. However, if the mating flange on the exhaust downpipe/catalytic converter assembly is not true it is possible a leak may occur.

14. Verify the mating flange on the exhaust downpipe/catalytic converter assembly is true.

- If the mating flange is true, no further action is required.
- If there are gaps the converter may need replacing, but the new gasket should compensate for minor surface variation. It is preferred that the alignment process is attempted prior to replacing the converter. There have been very few cases that required the converter to correct this condition. Refer to *Catalytic Converter Replacement (LGH /LML)* in SI.
