Technical Service Bulletin

70 Noises from the upper-center dashboard area

70 15 50 2029280/6 November 3, 2015. Supersedes Technical Service Bulletin Group 70 number 15-45 dated April 15, 2015 for reasons listed below.

Model(s)	Year	VIN Range	Vehicle-Specific Equipment
A6, A7	2012 - 2017	All	Not Applicable

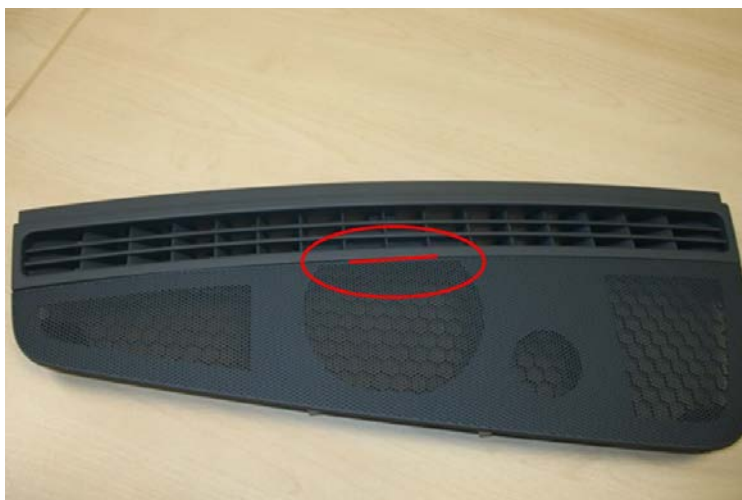
The noise can be caused by unfavorable tolerances between the instrument panel speaker and the center speaker trim. A speaker that has been incorrectly installed can make the condition worse.

Because there is no attachment to the trim carrier in the speaker cut-out, this area is the likely source of the vibration (Figure 1).

Figure 1. The affected area of the speaker grille, circled in red.

Replace the center defroster vent and the speaker trim. Review the steps below before proceeding:
