Technical Service Bulletin

40 Noise from front end (faulty wheel bearings)

40 15 48 2042603/1 December 4, 2015.

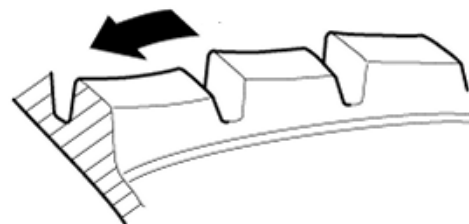
1. Before proceeding, check tires for heel and toe wear pattern (also known as saw tooth) or structural damage (Figure 1.).

Figure 1. Heel and toe wear pattern.

If either condition is present, this TSB does not apply. Diagnose tire conditions accordingly.
