74 Front seat side trim loose or broken

74 15 22 2042470/1 December 1, 2015.

Model(s)	Year	VIN Range	Vehicle-Specific Equipment
TT	2016	All	Not Applicable

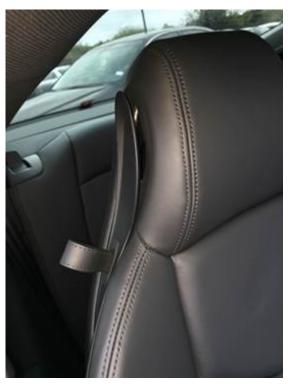
The trim on either side of the front seat backrest is loose or broken (Figure 1, Figure 2, and Figure 3).

Figure 1. Outer front seat side trim loose.

The material used in the construction of the trim pieces is of insufficient strength and can break under normal use.

- 1. Replace both side trim pieces of the affected seat only.
- 2. Replace loose or broken trim strips with replacement parts marked with "15S", following the instructions in Elsa at: Body>>Body Interior>>74 Seat Upholstery, Covers>>Front Seat Covers and Cushions>>Backrest Cover and Cushion, Removing and Installing>> Backrest Cover and Cushion, Removing and Installing, Super Sport Seat.

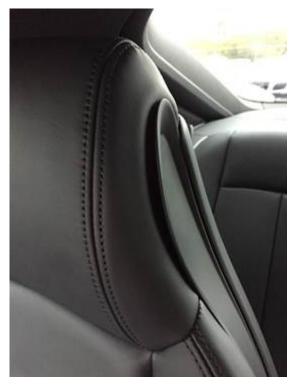
Figure 2. Inner front seat side trim loose.

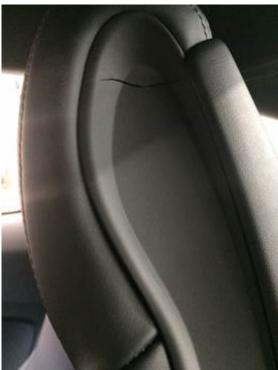
Figure 3. Front seat side trim cracked.

If a piece of trim has broken off, locate and remove the broken piece before reassembly. If the broken piece is not removed, it may cause a rattle noise.

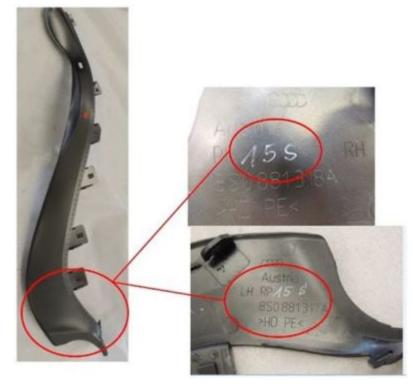
The latest improved version of the trim is marked on the inside of the trim with "15S" (Figure 4).

Figure 4. Location of the 15S version marking on the trim.
