Technical Service Bulletin

91 MIB MMI cannot be turned on, or other sporadic MMI concerns

91 15 27 2038073/2 December 9, 2015. Supersedes Technical Service Bulletin Group 91 number 14-57 dated August 11, 2014 for reasons listed below.

Model(s)	Year	VIN Range	Vehicle-Specific Equipment
A3	2015 - 2018	All	Not Applicable

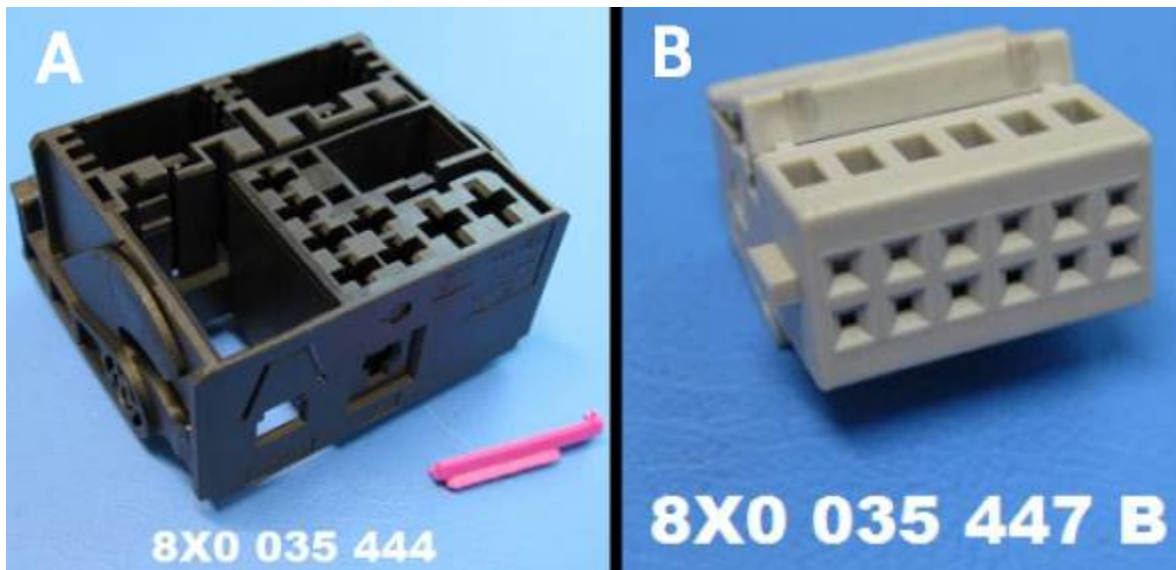
The grey 12-pin flat contact lock (Figure 1, B) is not correctly slotted in the quad lock housing (Figure 1, A).

Figure 1. Quad lock housing (A) and 12-pin flat contact lock (B).

4.
 - If the grey 12-pin flat contact lock is correctly slotted into the quad lock, this TSB does not apply. Continue diagnosis outside of this bulletin.
 - If the grey 12-pin flat contact lock is not (and cannot be) correctly slotted into the quad lock, replace both the quad lock and the grey 12-pin flat contact lock.
5. Make sure that all contacts and locks are in the correct position.

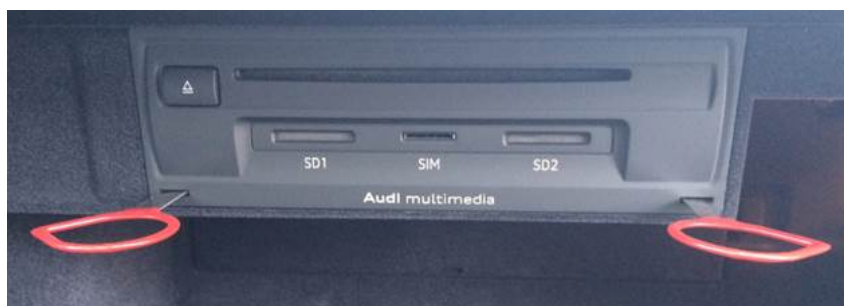
Figure 2. Remove the J794 module.

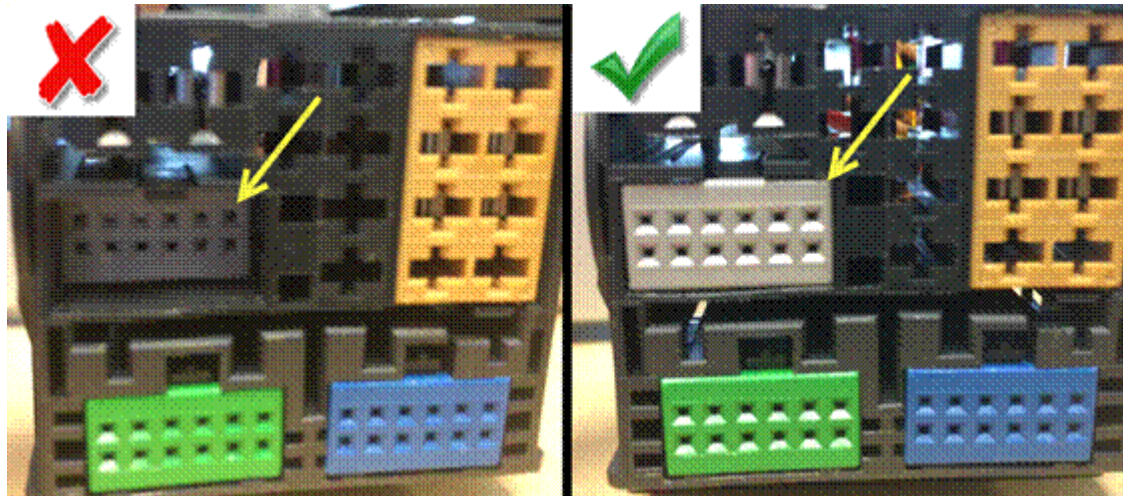
3. Remove the quad lock. Check the grey 12-pin flat contact lock to see if it is correctly slotted in the flat contact housing (Figure 3).

Figure 3. Grey 12-pin flat contact lock incorrectly slotted (left) and correctly slotted (right).
