Technical Service Bulletin

91 Audi connect online destination search, Google Earth navigation view, or INRIX online traffic is not available

91 15 28 2042013/2 December 9, 2015. Supersedes Technical Service Bulletin Group 91 number 15-17 dated September 29, 2015 for reasons listed below.

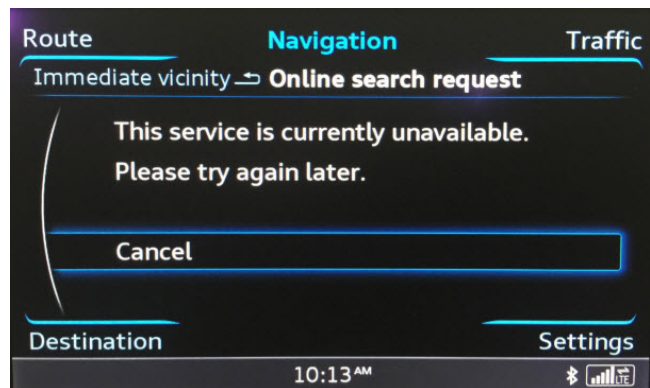
- While using Audi connect, the customer cannot access the online destination search and/or the Google Earth navigation view.
- The following message appears in the MMI (Figure 1): "This service is currently unavailable. Please try again later."
- The customer may also see an error message in the myAudi portal indicating that one or multiple licenses are expired and must be renewed.
- Additionally, if the vehicle is a model year 2016 A6, A7, or TT, the customer may not be able to see speed and flow traffic information in the navigation map screen, and may consistently see that no traffic reports are available. For these vehicles, traffic is provided by INRIX online.

Figure 1. Message in MMI.

There is a known issue with the licenses contained on the backend server for specific vehicles built within a certain date range. As a result, the online destination search and/or the Google Earth navigation view do not function. For model year 2016 A6, A7, or TT vehicles, the INRIX traffic service may not be available, and only shows "no traffic reports are available", but no error. This issue can be seen in the customer's myAudi portal with an error message indicating that the license is expired for online traffic. Performing the SVM recovery activation or replacing the SIM card or MMI hardware will not remedy the concern.

If only online destination search and/or the Google Earth navigation view are unavailable but all other Audi connect services (weather, fuel prices, etc.) are available (and, for model year 2016 A6, A7, or TT vehicles, there may be a complaint of no INRIX traffic and no online destination search and/or no Google Earth navigation):

1.
 - Collect the following information from the vehicle or customer:
 - Which services are working and which services are not working.
 - The time and date when the issue last occurred (include time zone).
 - The general metropolitan area where the issue last occurred.
 - Take a photo or screenshot of the error message on the MMI screen, or ask the customer what the error message stated. Uploading a photo is not required, but is helpful for communicating the concern to AUDI AG.
2. Contact TAC and include the information above.

3. Return the vehicle to the customer. No additional analysis is required after the data listed in step 1 has been correctly provided to TAC.
4. When a solution is provided, the dealer or customer will be notified. After the change is made on the AUDI AG backend server, the service will automatically start working in the MMI after the vehicle has gone through at least one ignition key cycle off/on.
