Technical Service Bulletin

48M2 UPDATE – Power Steering Control Module Software Update (NVLW)

December 8, 2015

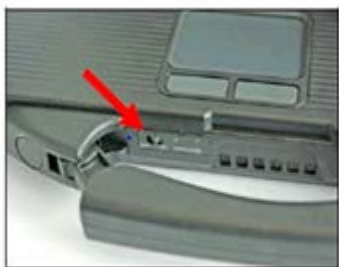
VAS 6150 & VAS 6150A
(Front panel behind handle)

The Bluetooth function of the scan tool **MUST BE PHYSICALLY SWITCHED OFF** prior to performing this update. <See pictures>
