Technical Service Bulletin

01 MIL on (DTC P0491/P0492 secondary air system bank 1/2 through-flow too low/malfunction)

01 15 46 2035002/2 October 8, 2015. Supersedes Technical Service Bulletin Group 01 number 13-25 dated August 23, 2013 for reasons listed below.

Model(s)	Year	VIN Range	Vehicle-Specific Equipment
A8	2010 - 2012	All	4.2FSI

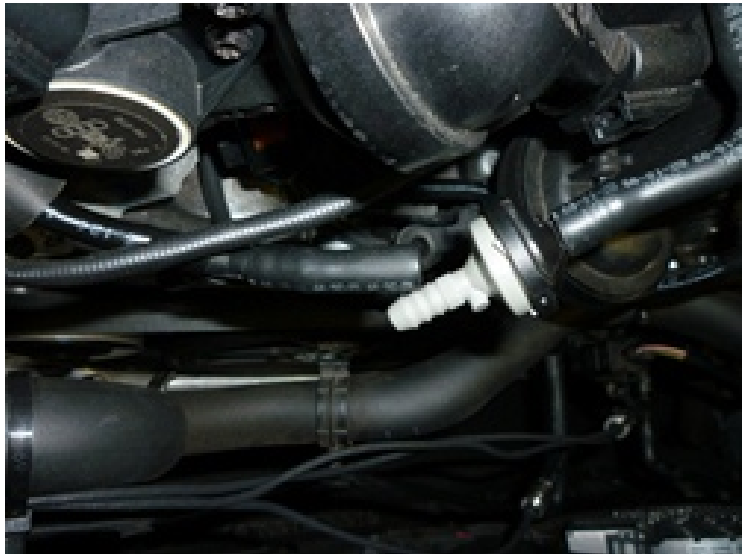
Figure 1. Vacuum check valve.

1. Check the vacuum check valve for leaks (Figure 1). The direction of flow should only be towards the intake manifold.

If a leak is found at the check valve, replace the valve and recheck.

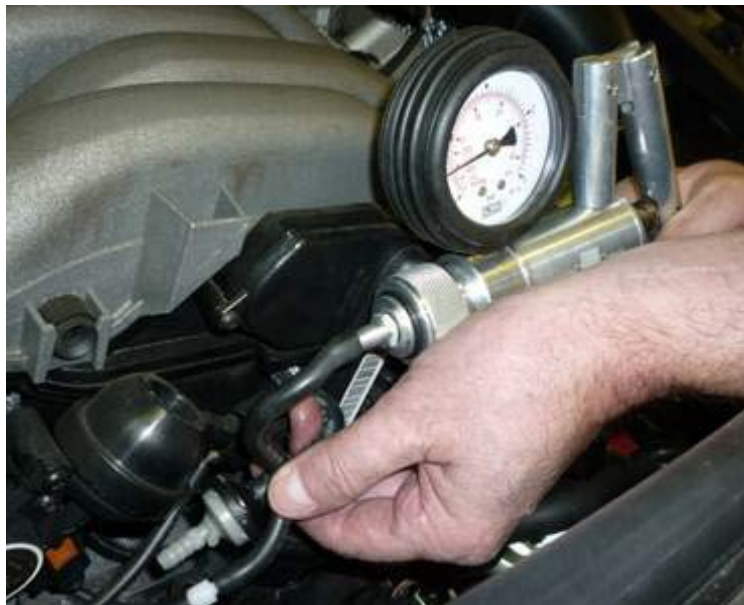
Figure 2. VAS 6213 hand vacuum pump

2. With the hose to the check valve disconnected, apply 400 mmHG of vacuum with the VAS 6213 hand vacuum pump (Figure 2).

If the vacuum supply drops during the first 10 minutes of the test, check all pipes of the vacuum system and solenoid changeover valves for leaks. Repair as necessary.

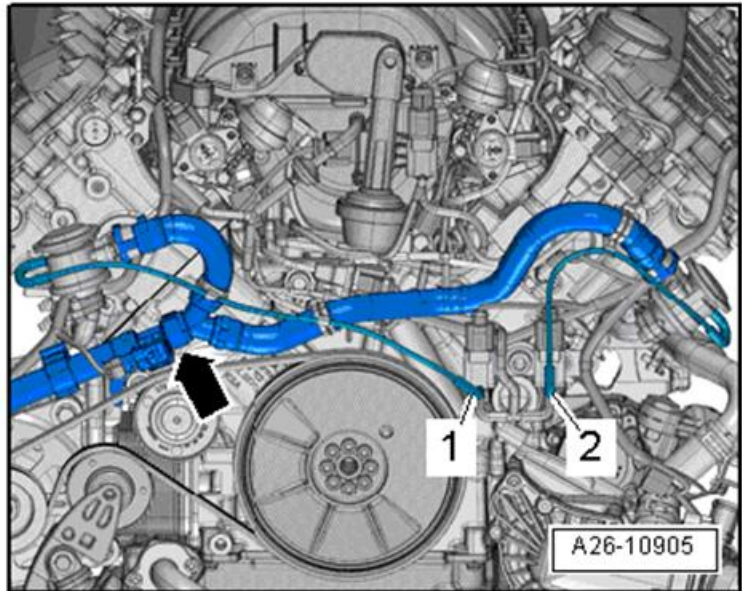
Figure 3. Solenoid valves N112 and N320 (1 and 2)

3. Disconnect the vacuum hoses to the solenoid valves N112 and N320 (Figure 3, 1 and 2), then connect the VAS 6213 to the hoses, one at a time.

If the vacuum supply drops during the first 10 minutes of the test, check all pipes of the vacuum system. Repair as necessary.
