# Technical Service Bulletin

## 01 MIL on (DTC P0491/P0492 secondary air system bank 1/2 through-flow too low/malfunction)

01 15 47 2035002/3 October 22, 2015. Supersedes Technical Service Bulletin Group 01 number 15-46 dated October 8, 2015 for reasons listed below.

Model(s)	Year	VIN Range	Vehicle-Specific Equipment
A8	2010 - 2012	All	4.2 FSI

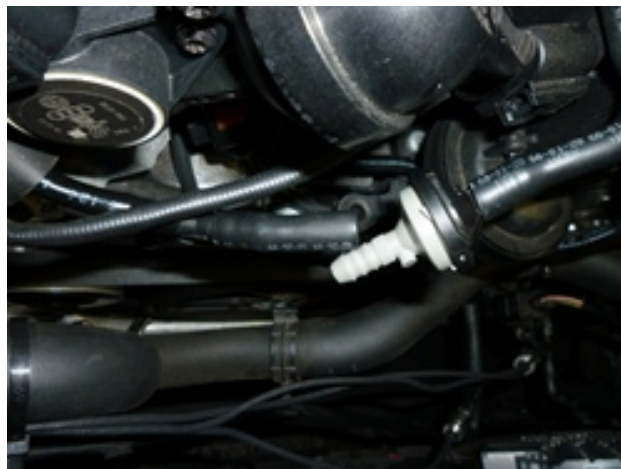
*Figure 1. Vacuum check valve.*

1. Check the vacuum check valve for leaks (Figure 1). The direction of flow should only be towards the intake manifold.

If a leak is found at the check valve, replace the valve and recheck.

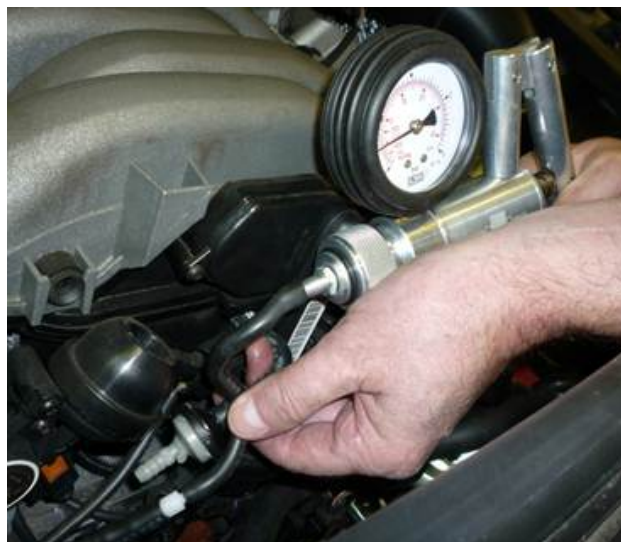
*Figure 2. VAS 6213 hand vacuum pump*

2. With the hose to the check valve disconnected, apply 400 mmHG of vacuum with the VAS 6213 hand vacuum pump (Figure 2).

If the vacuum supply drops during the first 10 minutes of the test, check all pipes of the vacuum system and solenoid changeover valves for leaks. Repair as necessary.
