Technical Service Bulletin

46 Brake noise analysis and handling

46 15 23 2034181/12 October 13, 2015. Supersedes Technical Service Bulletin Group 46 number 15-02 dated February 9, 2015 for reasons listed below.

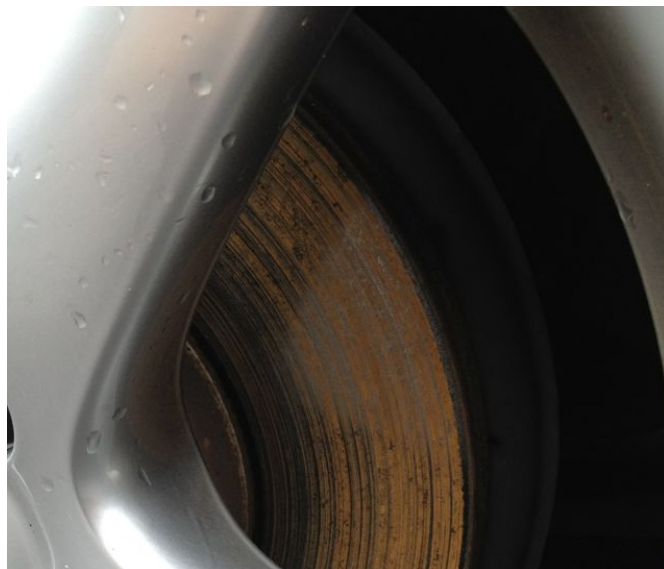
- Discs are covered with rust. Rust can form when the vehicle has not been driven for a long period of time (Figure 1).

Figure 1. Disc covered with rust.

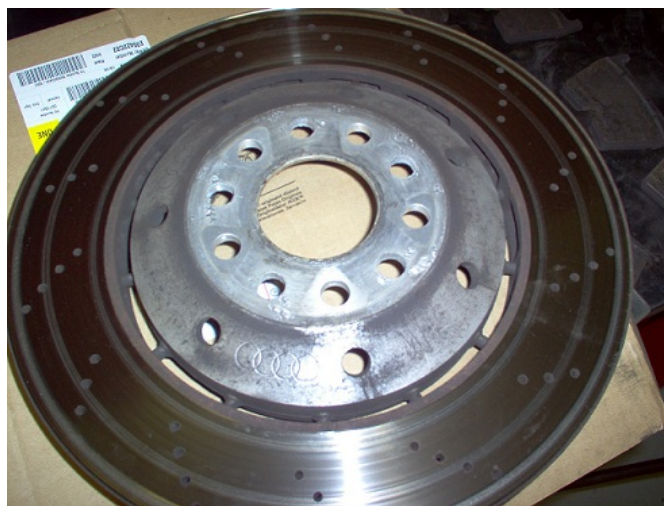
- Discs are grooved (Figure 2).

Figure 2. Grooved disc.

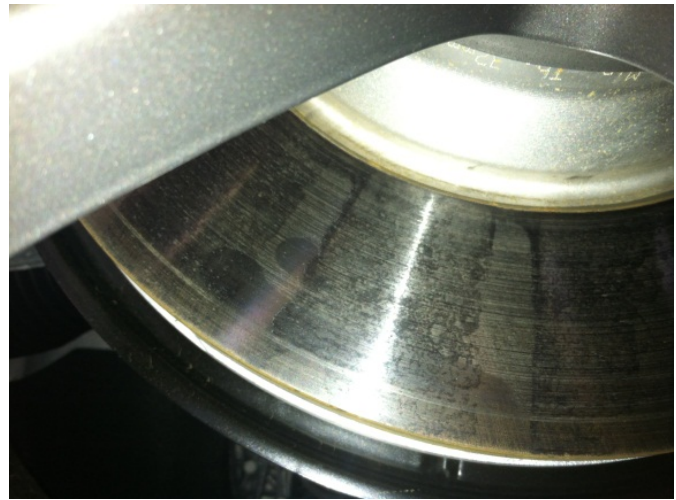
7. There is chemical contamination on the braking surface of the brake disc due to wheel or tire cleaner being sprayed directly onto the brake disc (Figure 3 and Figure 4).

Figure 3. Discoloration on the brake disc due to chemical contamination from cleaner that was sprayed directly onto the disc.

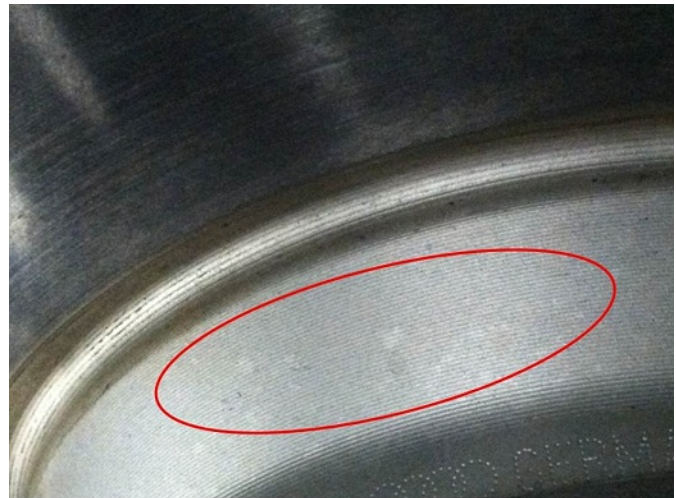
Figure 4. Small spots and discoloration due to chemical contamination from cleaner that was sprayed directly onto the disc.

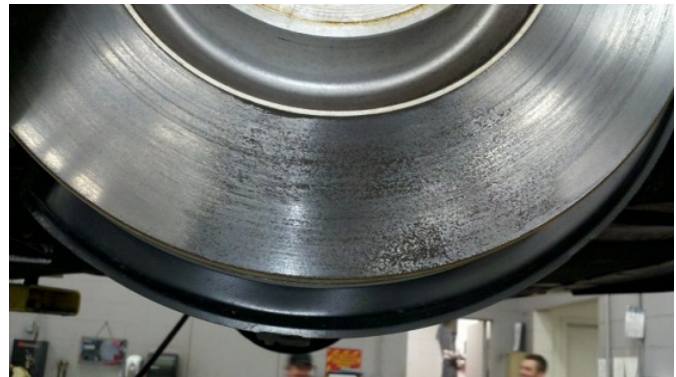
8. There are “pad marks” on the brake disc as a result of brake pad material transferring to the discs (Figure 5). Pad marks can occur when a vehicle has been parked for long periods of time in a wet or snowy environment.

Figure 5. Brake pad material has transferred to the discs.
