Technical Service Bulletin

57 Door handle touch sensor sporadically inoperative

57 15 14 2042249/1 October 19, 2015.

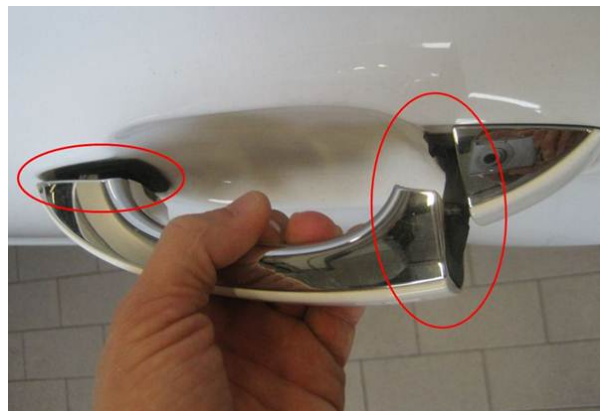
Figure 1. Clean handle in circled areas.

**Tip:** Advanced key function can be affected by dirt. Before replacing door handle, clean the handle to see if function is restored (Figure 1).
