Technical Service Bulletin

70 Noises from headliner / sunroof area

70 15 48 2038029/4 October 14, 2015. Supersedes Technical Service Bulletin Group 70 number 15-47 dated September 21, 2015 for reasons listed below.

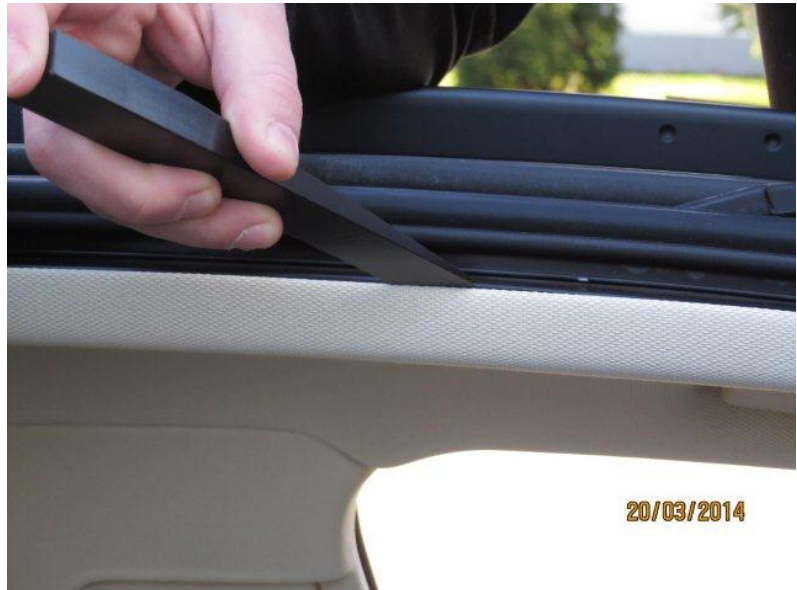
Figure 1: Unclipping the sunroof cover trim frame.

1. Remove the glass sliding roof panel(s). Remove the beam for the sunroof rollershade. Carefully unclip and remove the sunroof cover trim frame (Figure 1).

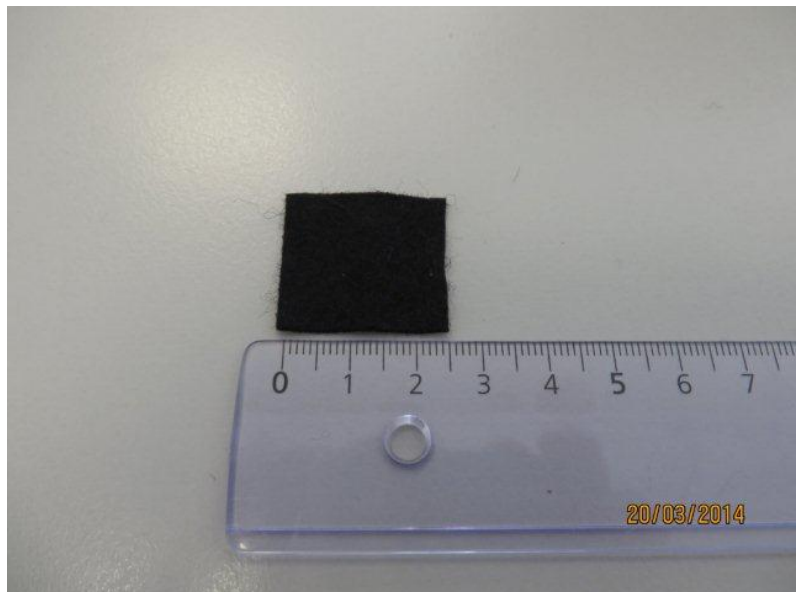
Figure 2: A 25mm section of fleece adhesive tape 533867910A.

2. The number of retaining clips will vary by model. A piece of dampening tape (fleece adhesive tape 533867910A) will be applied to each clipping point. Cut pieces of the tape 25mm long (Figure 2).

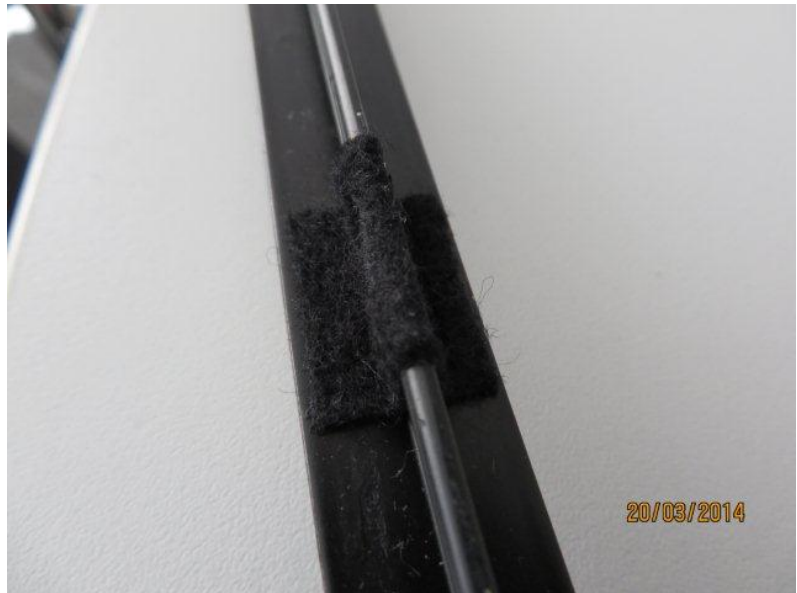
Figure 3: Fleece tape section applied.

3. Apply the sections of fleece tape to the sunroof cover trim frame to each clipping point as shown (Figure 3 and Figure 4).

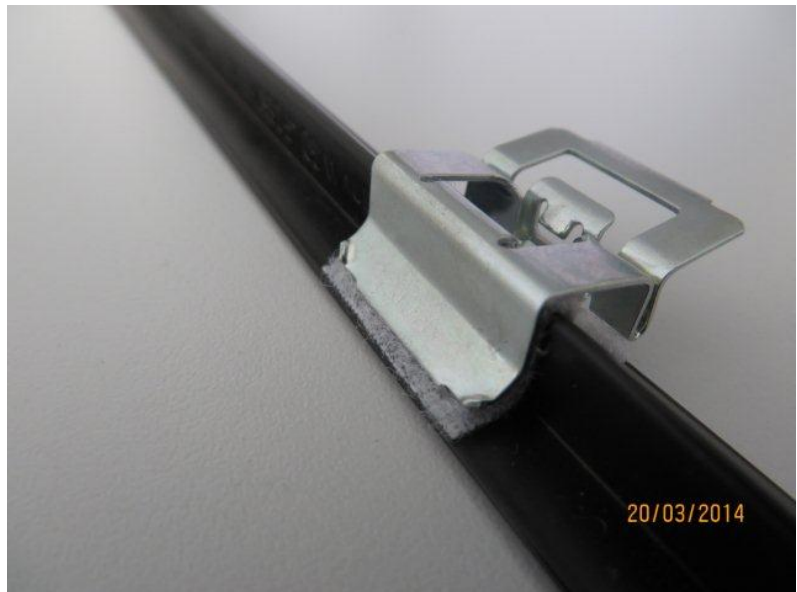
Figure 4: Retaining clip isolated with the fleece tape.

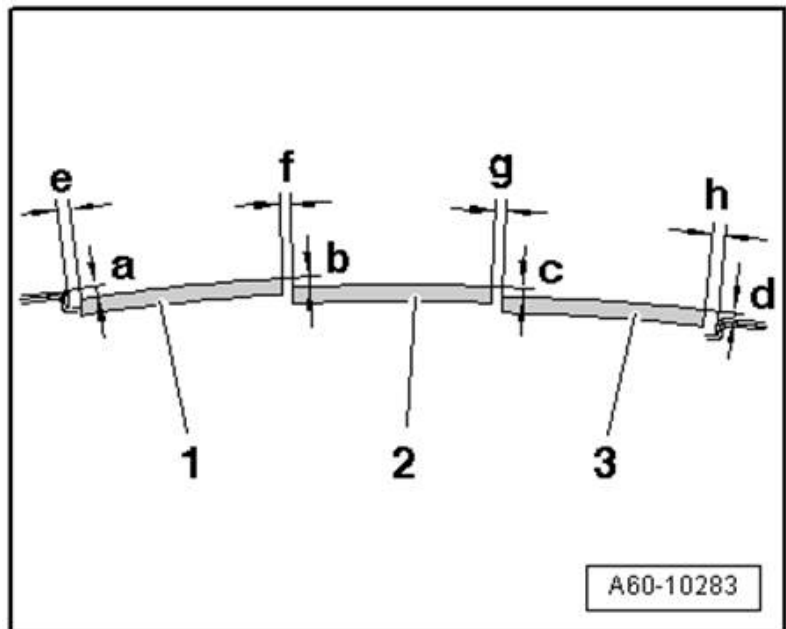
Figure 5: Adjustment of the glass sliding roof panels.

4. Reassemble the components removed for this modification. Ensure that the glass sliding roof panels are adjusted properly according to the repair manual (Figure 5).
