Technical Service Bulletin

91 Rearview camera intermittently inoperative (DTC 2203)

91 15 19 2041430/2 October 15, 2015. Supersedes Technical Service Bulletin Group 91 number 15-04 dated July 22, 2015 for reasons listed below.

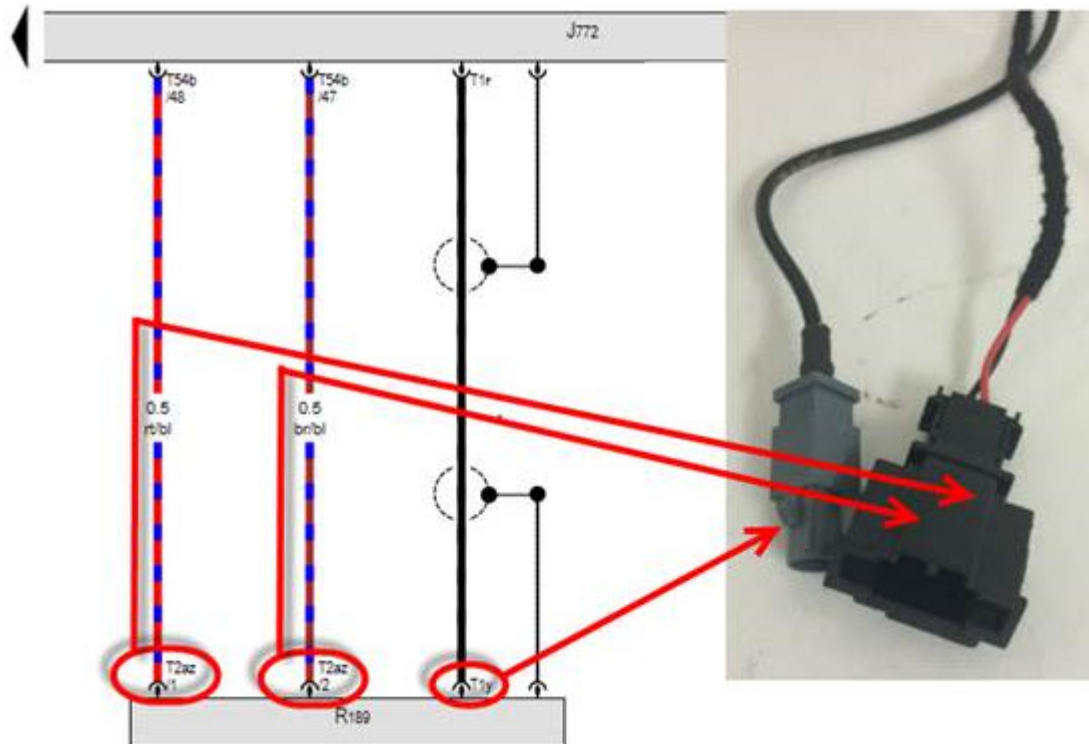
- The customer complains that the rearview camera image is not displayed on the MMI display.
- **DTC 02203** (audio/video input 1) is logged in the rearview camera system control module, J772 (address word 6C) with one of the following fault symptoms:
 - 11 open circuit
 - 8 implausible signal

An issue with the wiring harness may cause the condition.

Figure 1. Check the wiring of the R189 reverse camera at connector T2az and T1y.

1. Before proceeding, confirm that the DTC and one of the fault symptoms listed in the *Condition* are logged in the rearview camera system control module, J772 (address word 6C). If the DTC is not listed with one of the fault symptoms, this bulletin does not apply.
2. Check the wiring of the R189 reverse camera at connector T2az and T1y (Figure 1). Repair any loose connectors or pins, corrosion, or any other physical damage.

3. If no problems are found with the wiring or connections of the rear view camera as shown in step 2, replace the rear view camera.
