Technical Service Bulletin

91 MMI3G+ Audi connect only reaches 2G service - Telephone module replacement instructions for A4,A5,A5 cab,Q5,Q7,A8

91 15 21 2039476/5 October 16, 2015. Supersedes Technical Service Bulletin Group 91 number 15-06 dated July 28, 2015 for reasons listed below.

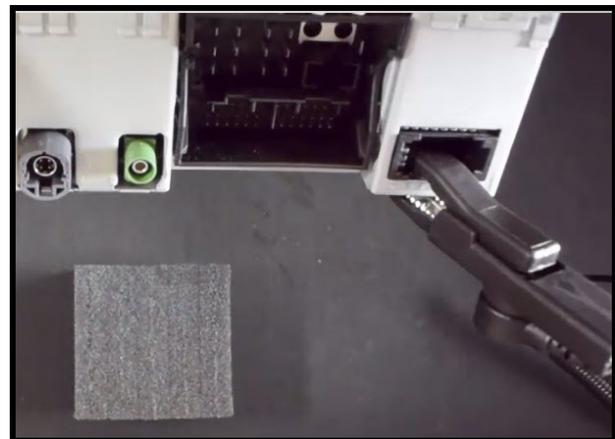
Figure 4. VAS6613 ESD work surface grounding device clip.

6. Ground the MMI main unit by placing an alligator clip on the back, ensuring that it makes contact with the metal housing of the main unit. The most secure location is at the MOST connector (Figure 4).

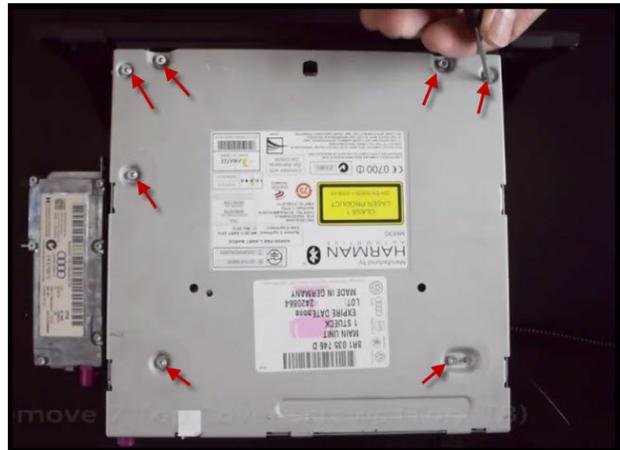
Figure 5. MMI main unit with screw locations for top cover indicated by the red arrows.

7. Remove the seven screws that are holding the MMI top cover in place (Figure 5).

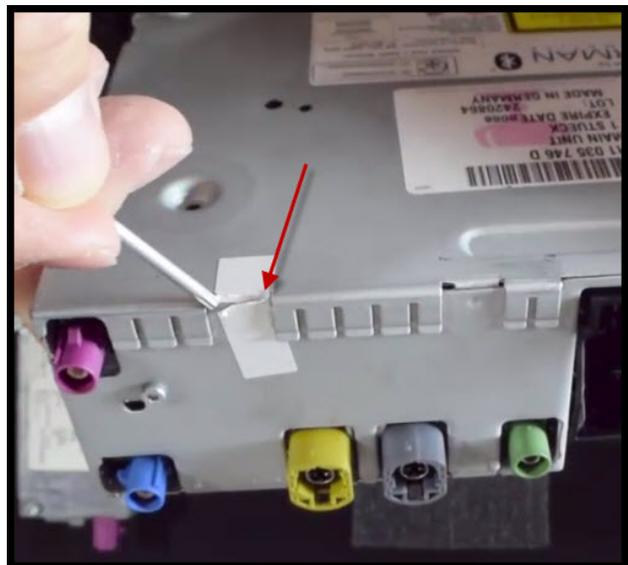
Figure 6. Break white warranty seal.

8. Break the white warranty seal on the back of the main unit (Figure 6).

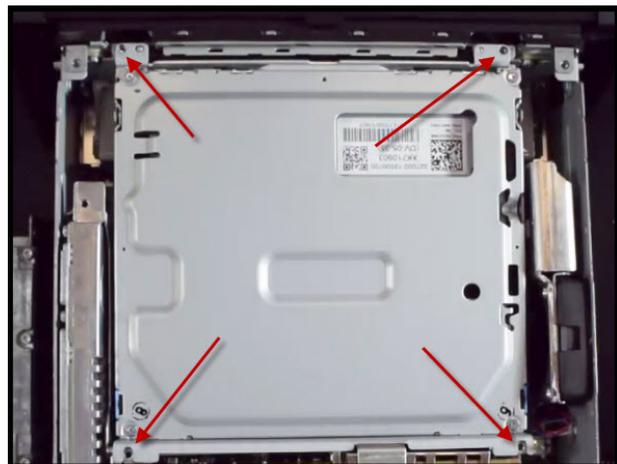
Do not flip the main unit over at this point. The CD drive, which was held in place by the top cover screws, is no longer secured. If it moves significantly, the ribbon cable can detach from the circuit board and disable the CD drive's functionality (Figure 9).

Figure 9. CD drive mounting points are free to move.

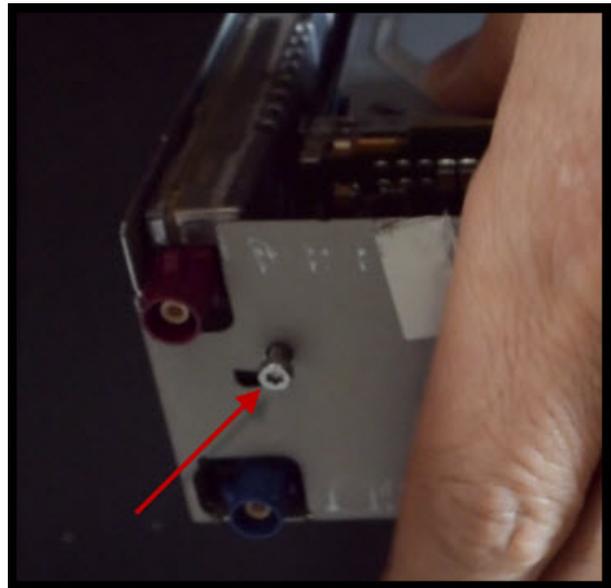
Figure 10. Telephone module retaining screw indicated by the red arrow.

10. On the back of the main unit, remove the retaining screw that holds the telephone module in place (Figure 10).

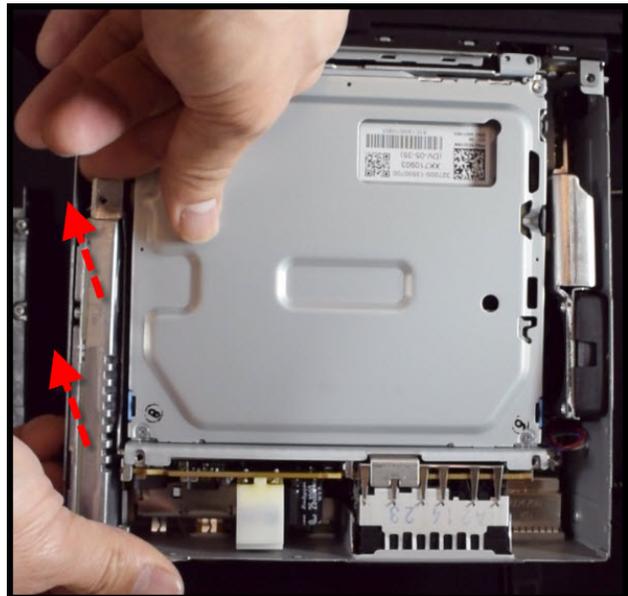
Figure 11. Lift up on both ends of the telephone module as indicated by the red arrows.

11. Carefully lift up the telephone module, using both ends as points of contact when pulling up (Figure 11). The module is held in place with a computer socket-type attachment and will release when enough force is used.

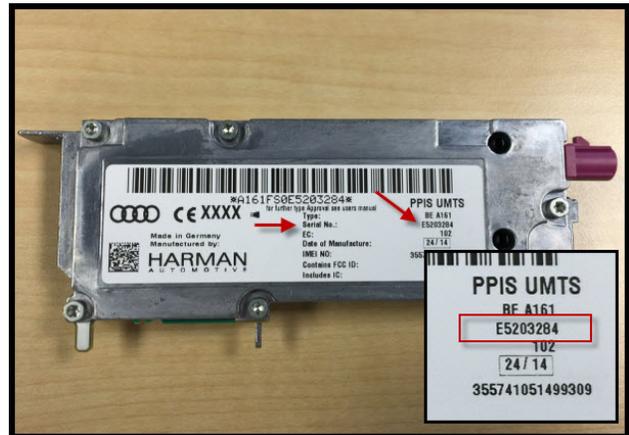
Figure 12. Serial number of the PPIS UMTS telephone module indicated by the red arrows and red box.

12. Before proceeding, write the serial number of the new replacement UMTS telephone module on the rework label (Figure 12).

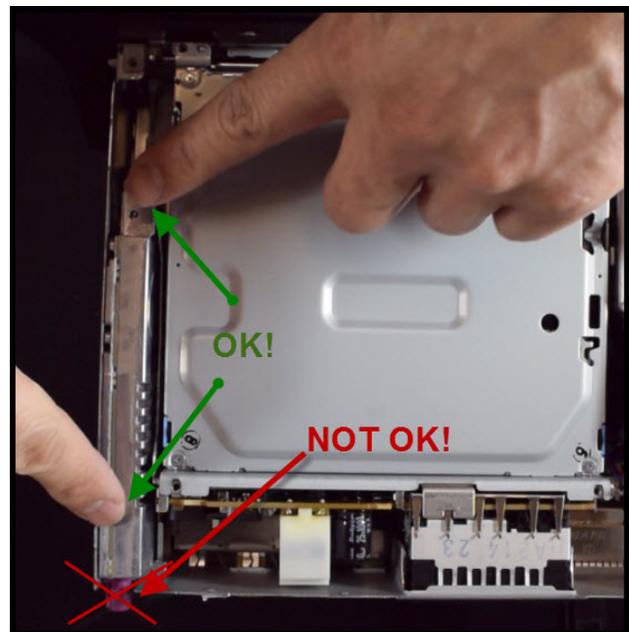
Figure 13. Do not press down using the purple FAKRA connector.

13. Place the new UMTS telephone module into the socket, making sure it is level before snapping it into place. Use both ends of the telephone module when pressing it into place. Do not press down using the purple FAKRA connector (Figure 13).

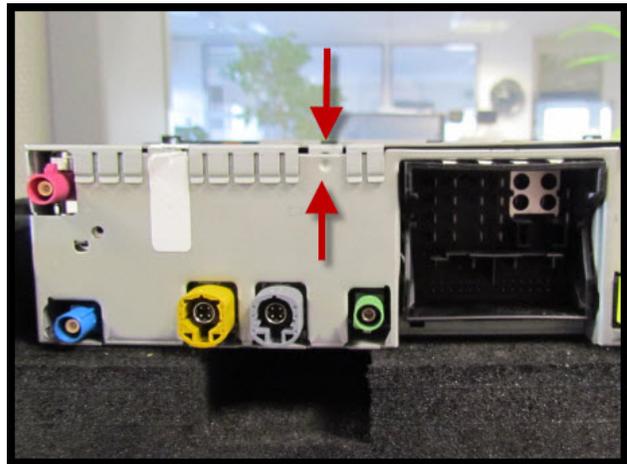
Figure 14. Place the new warranty seal over the location indicated by the red arrows.

17. Place the new warranty seal from the retrofit kit next to the original warranty seal (Figure 14).

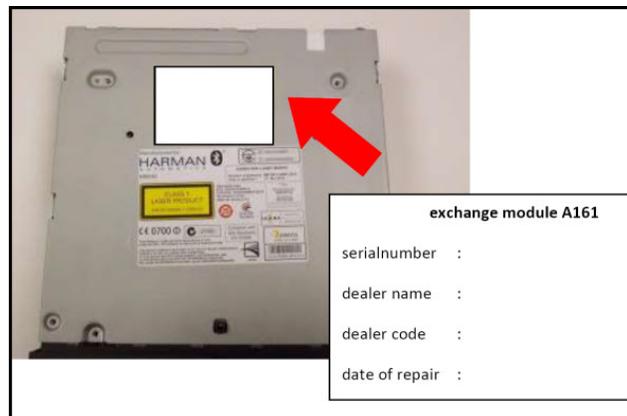
Figure 15. The white area indicates the “suggested” location for the repair label on the top cover of the main unit. Do not cover any existing part number labels.

18. Place the rework label on the top of the main unit cover. Do not cover any part number labels (Figure 15). Fill out all fields on the repair label.
