# Audi Elsa Newsletter

Edition 159: October 26, 2015

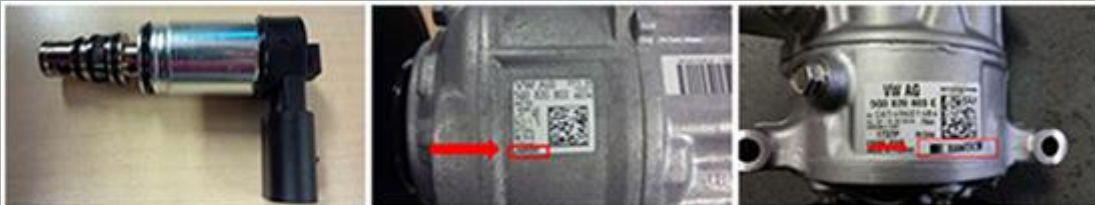
| <b>87 Air conditioning does not cool and / or compressor is noisy (2038023/7)</b> | | |
|---|---|---|
| <b>Condition:</b> <ul style="list-style-type: none"> <li>One or more of the following conditions are exhibited: <ul style="list-style-type: none"> <li>The air conditioning does not cool, or the cooling performance is very weak.</li> </ul> </li> </ul> | | |

- The air conditioning system cools, but the compressor is noisy. The noise is characterized as a grinding or groaning noise.
- Either symptom may be intermittent.
  - No DTCs are stored.

Figure 1. N280 Refrigerant Regulating Valve. Figure 2. Denso compressor identification tag. Figure 3. Sanden compressor identification tag.

**Production Solution:** Denso A/C compressors are currently being installed in production (Figure 2 and Figure 3).

An improved N280 valve for the Sanden A/C compressor is now available as a replacement part (5Q0 260 839 A). Replacement of the entire A/C compressor is not necessary in most cases.
