Technical Service Bulletin

35 Leaks from transmission

35 15 18 2028085/5 September 18, 2015. Supersedes Technical Service Bulletin Group 35 number 13-12 dated June 18, 2013 for reasons listed below.

Model(s)	Year	VIN Range	Vehicle-Specific Equipment
S4, S5, S5 Cabriolet, RS5, S6, S7	2010 - 2016	All	0B5 S-Tronic transmission

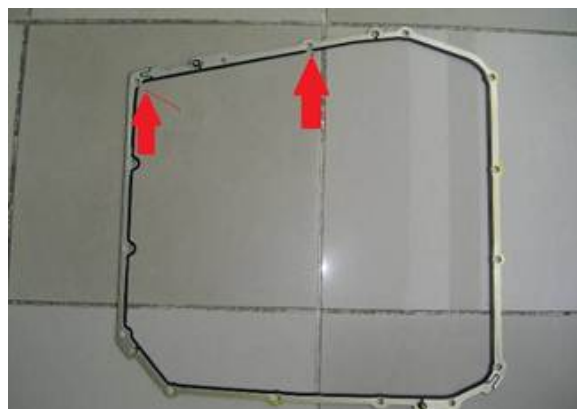
- Leaking from the oil pan seal (Figure 1).

Figure 1. Leak on the oil pan seal (red arrows).

- If the oil pan is undamaged, replace only the oil pan seal.
 - If the oil pan is damaged (Figure 5), check the mechatronics for loose bolts (Figure 6). Replace any loose bolts and torque according to the repair manual instructions. Replace both the oil pan and seal.

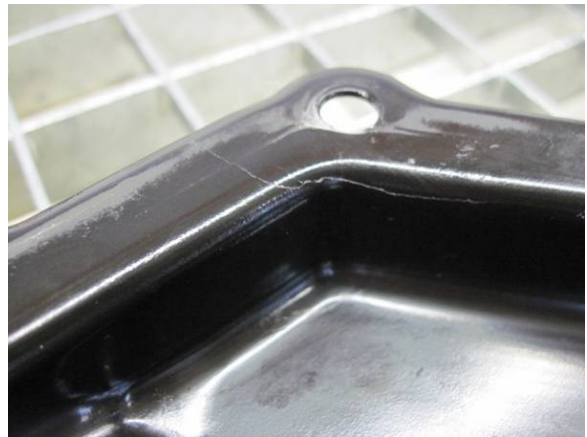
- Crack in the oil pan (Figure 2).

Figure 2. Crack in the oil pan.

- If pan is cracked (Figure 2, above) and no loose bolts on the mechatronics unit are found, replace oil pan and seal.
 - If there is a leak between gearbox housing and intermediate housing (Figure 3, above), reseal the case by following instructions in *Elsa >> Repair manual >> Transmission >> S Tronic Transmission Internal Components >> 35 Gears, Shafts >> Removal and Installation >> Sensor Module with Transmission Input Speed Sensor - G612-, -G632-, -G676- and Circuit Board 3.*

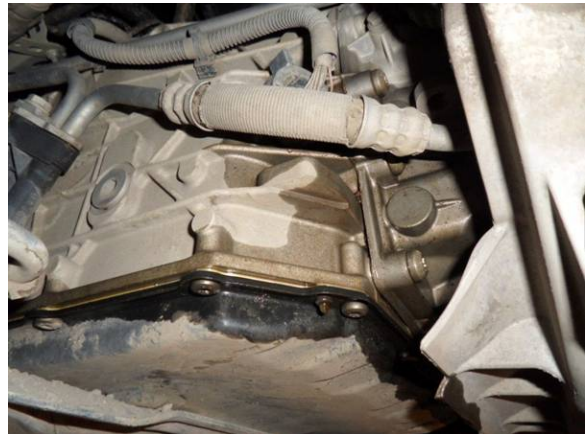
- Leak between gearbox housing and intermediate housing (Figure 3).

Tip: The source of the leak may be confused with o-ring of drain plug.

Figure 3. Leak between gearbox housing and intermediate housing.

Note: These instructions require transmission case disassembly. Audi Academy course #950224 and assessment #950224B must be completed before the repair is attempted or the warranty claim may be denied. The course and assessment can be found on the Audi Academy CRC site.

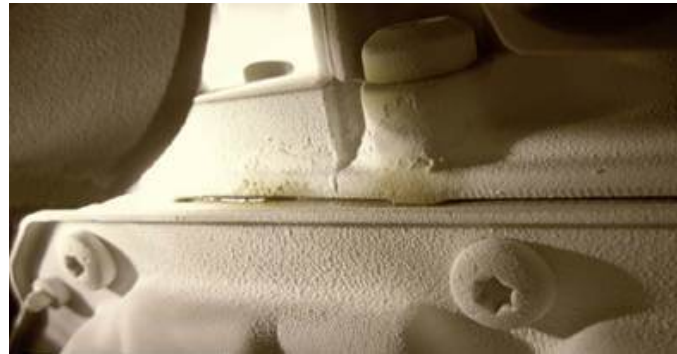
Figure 4. Leak located with talcum spray.

1. Locate the leak by first thoroughly cleaning and drying the stained area. Then, apply talcum spray (or similar) to the area that was stained with oil (Figure 4).

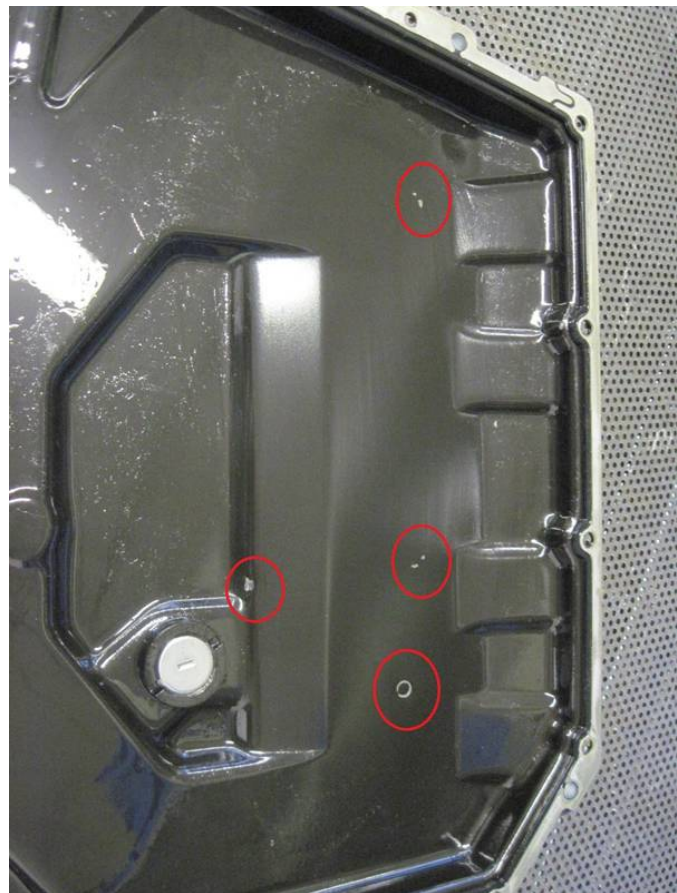
Figure 5. Damaged oil sump because of loose bolts.

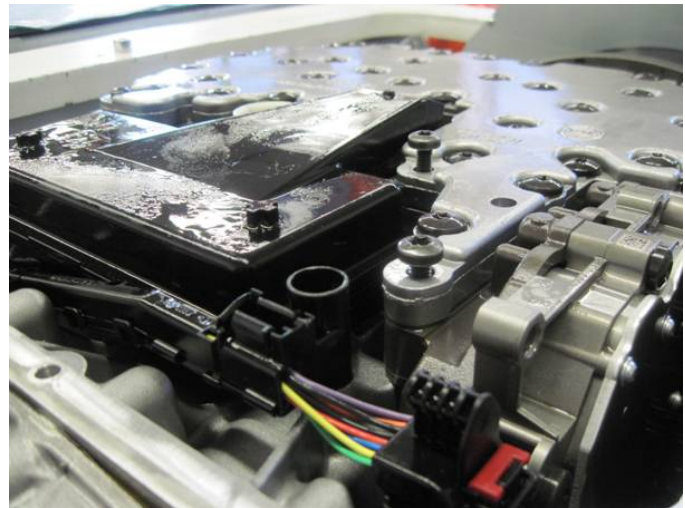
Figure 6. Loose bolts in the mechatronics.

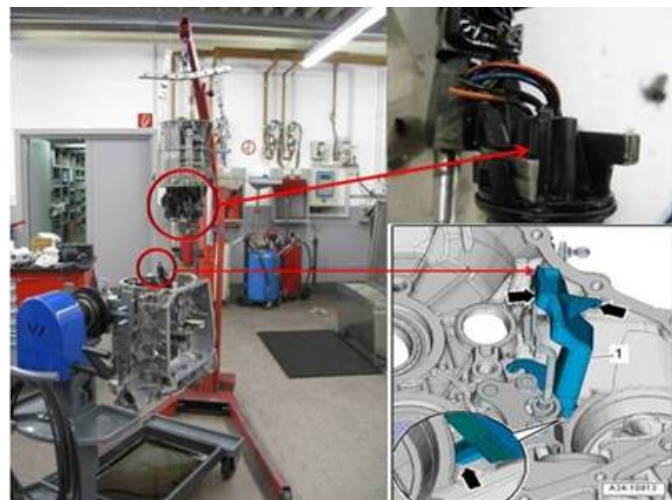
Figure 7. Caution points: drip tray Sensor module connector.

Tip: Use caution when lifting or lowering intermediate housing to avoid damage to components (Figure 7).
