## Technical Service Bulletin

#### 91 Antenna technical problem message (DTC 02617)

91 15 13 2041940/1 September 23, 2015.

Model(s)	Year	VIN Range	Vehicle-Specific Equipment
A4, A5	2016	All	Not Applicable

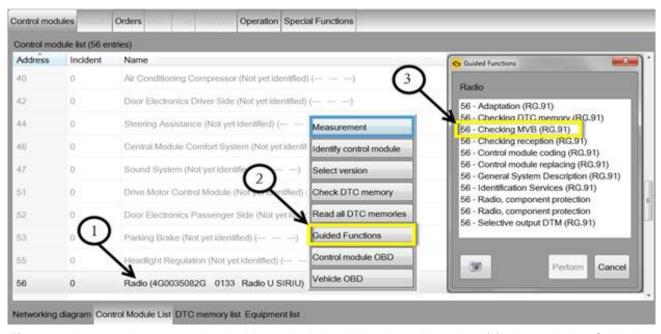
**Figure 2.** Access radio measured value blocks by right-clicking the radio module (1), then selecting Guided Functions (2), then selecting Checking MVB (RG.91) and clicking Perform. (Shown for MMI 3G+.)

- 1. Check the current consumption of the shark fin antenna through ODIS GFF.
- 2. In ODIS GFF, access the measured value blocks of the radio (address word 56) (Figure 2).

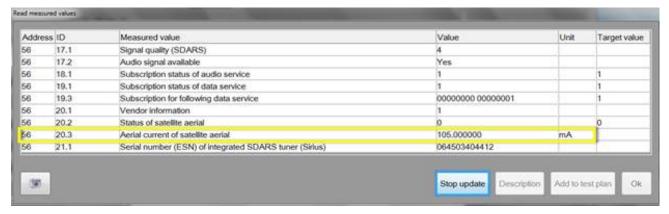
- 4. Check the current consumption of the satellite radio antenna (MVB 20.3 for MMI 3G+; MVB 9.3 for CAN radio) (Figure 4):
  - If the current consumption shown on an MMI system is between 40mA 100mA, proceed to step 5.
  - If the current consumption of the antenna is above 100mA, this TSB does not apply. Continue to diagnose
    the concern outside of this TSB.

Figure 4. Check the current consumption of the satellite radio antenna. (Shown for MMI 3G+.)

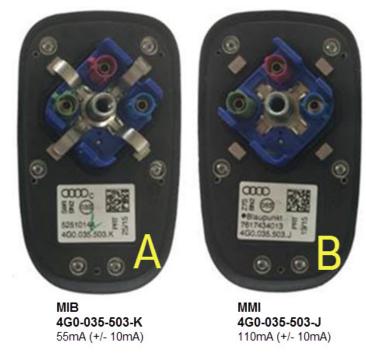
Visually, the MMI and MIB antennas are the same, but each antenna draws a different amount of current. For this reason, if an MIB antenna has been installed on a vehicle with an MMI radio, it causes an open circuit DTC. The open circuit DTC will be set on an MMI radio if the current draw from the antenna falls below 60mA.

- A MIB antenna draws 55mA (+/- 10mA) 4G0-035-503-K
- A MMI antenna draws 110mA (+/- 10mA) 4G0-035-503-J

**Figure 5.** MIB antenna with K suffix part number 4G0-035-503-K (A), and MMI antenna with J suffix part number 4G0-035-503-J (B).

5. Remove the satellite radio antenna and inspect the part number. If an MIB antenna (with a K suffix part number) is installed on an MMI system, replace the antenna with an MMI antenna (with a J suffix part number) (Figure 5).
