- PCJ OIL PRESSURE SENSOR REPLACEMENT
- PISTON COOLING REDUCTION VALVE REPLACEMENT
- ATS DOSER MODULE REPLACEMENT

Prevost vehicles

## PART 1 - PCJ OIL PRESSURE SENSOR REPLACEMENT

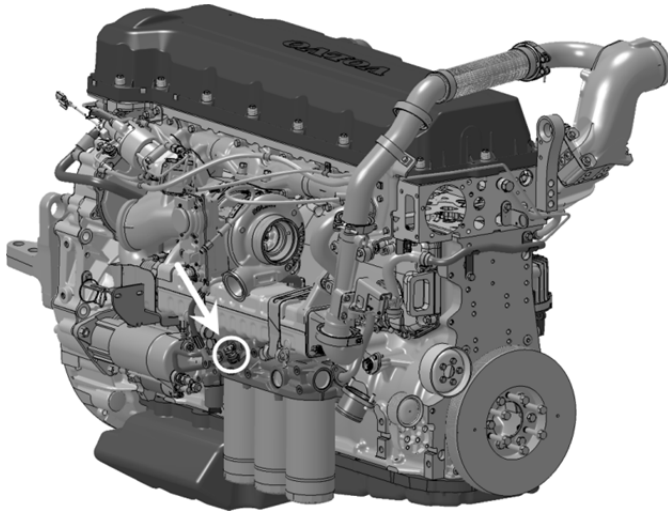
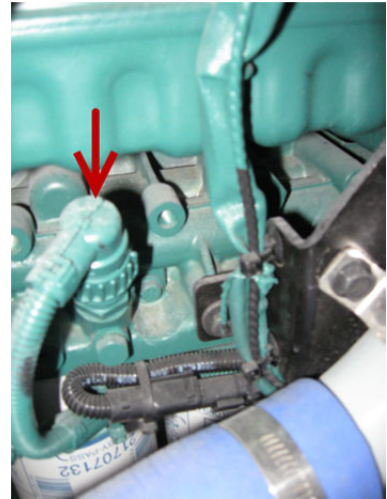
On the vehicles affected by this bulletin, the PCJ oil pressure sensor has to be replaced with an updated pressure sensor to avoid erroneous low oil pressure diagnostic codes.

- 1) Disconnect the PCJ sensor connector rotating the knurled collar counterclockwise. See the image below to locate the sensor.

- 2) Unscrew the sensor from the oil filter housing.
- 3) Clean out the electrical connector pins and sensor mounting surface with contact cleaner.
- 4) Install the new PCJ sensor (p/n 21634021). Torque:  $18.5 \pm 2$  ft-lb.
- 5) Reinstall the connector and rotate clockwise to lock.
- 6) Run the engine and check for leaks.
