PREVOST

WARRANTY BULLETIN

WB15-13

DATE :	MARCH 2015	SECTION :	16 - Suspension
EXPIRATION:	MARCH 2017		
SUBJECT :	IFS LEVEL VALVE CONTROL ROD POSSIBLE CONTACT

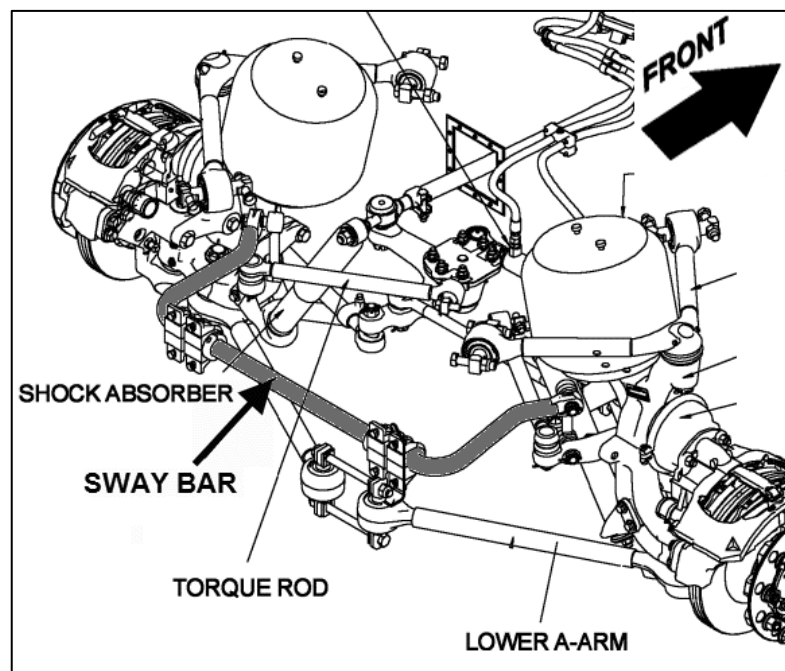
Figure 1

1. On the front axle, locate the front suspension sway bar. (Fig. 1)

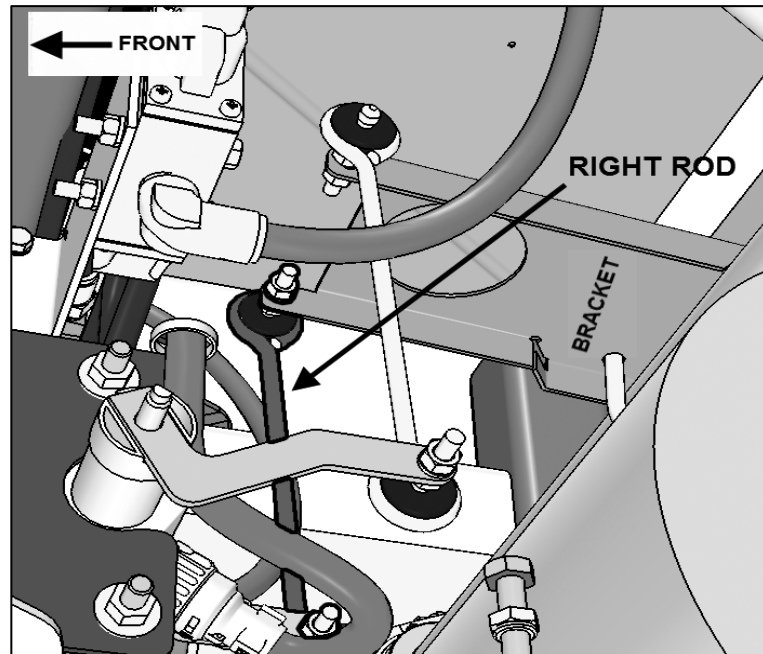
Figure 2

2. In the middle of the sway bar you will find a bracket clamped on the tube. The bracket supports two control rods (Fig. 2)

3. On the right hand side rod. (Fig.2) Unscrew the upper and lower mounting nuts.
4. Flip the rod over to the opposite side of the control lever and bracket tab above. (Arrow, Fig. 3)
5. Re-assemble hardware. (Fig.3)

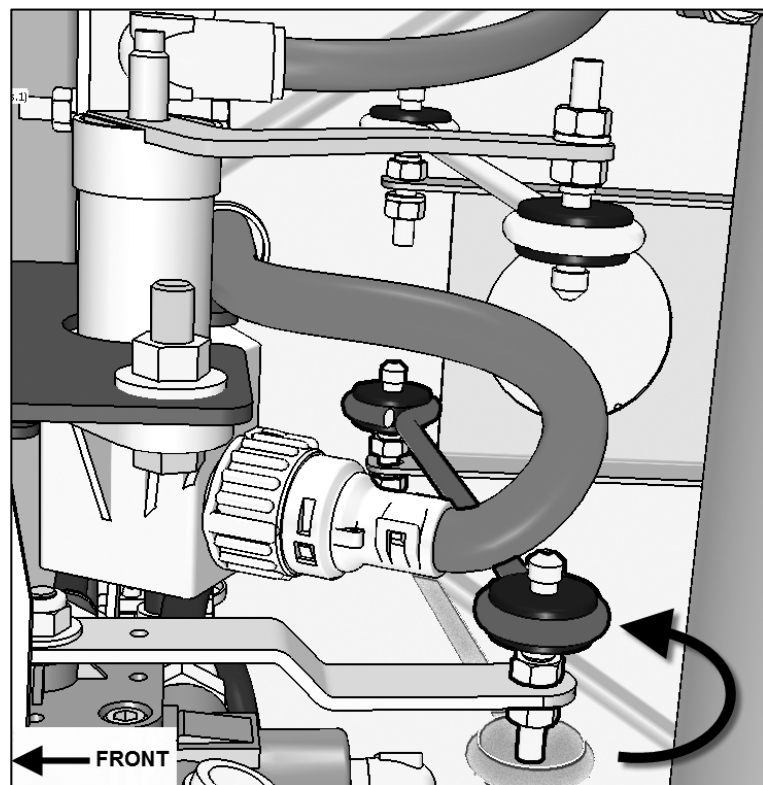
On the independent front suspension level valve linkage of the vehicles affected by this bulletin, a control rod may come in contact with an air reservoir outlet when vehicle rises from Low to High Buoy. As a result, the vehicle may be leveled higher in "Normal" position.

Figure 3 : Flip upper and lower connection of control rod.
