## SEALING IN AUXILIARY HEATER COMPARTMENT

Prevost vehicles

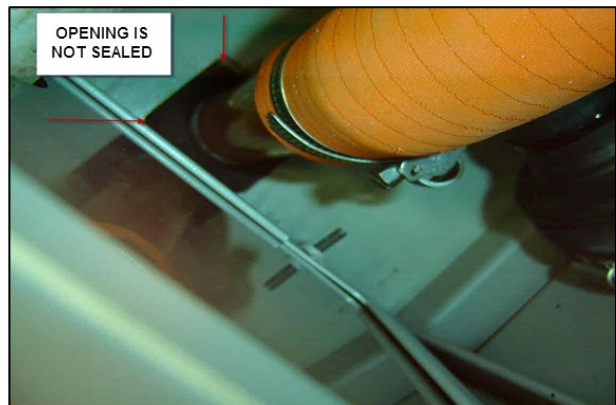
On the vehicles affected by this bulletin, seal a tube passage between the Auxiliary heater compartment and the heating duct in the passenger's compartment.

Seal the tube opening in the ceiling of the Auxiliary heater compartment with #684517 Simson sealing compound.
