Special Bulletin

SP15-323B

DIFFUSER PIPE WRAP INSTALLATION Prevost vehicles

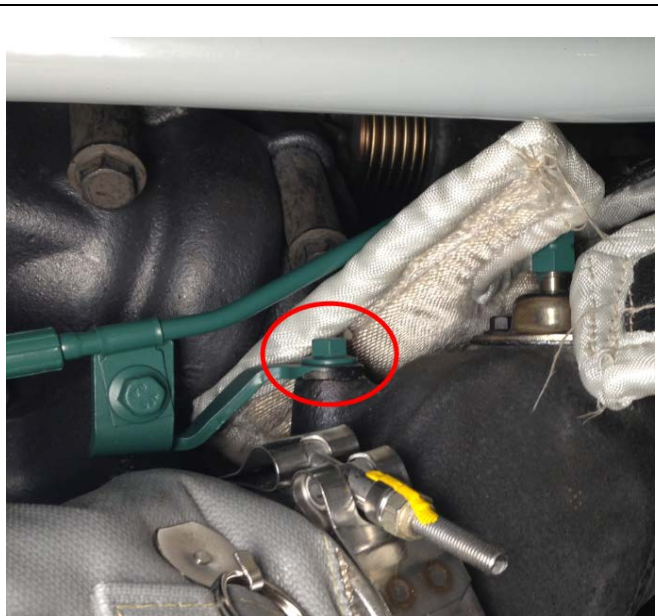
Be careful not to damage the inner side of the insulating wrap with the support retaining bolt as shown in the picture on the right.

A piece of tape over the bolt can be used to protect the wrap during installation.

Do not forget to remove the tape after installation!

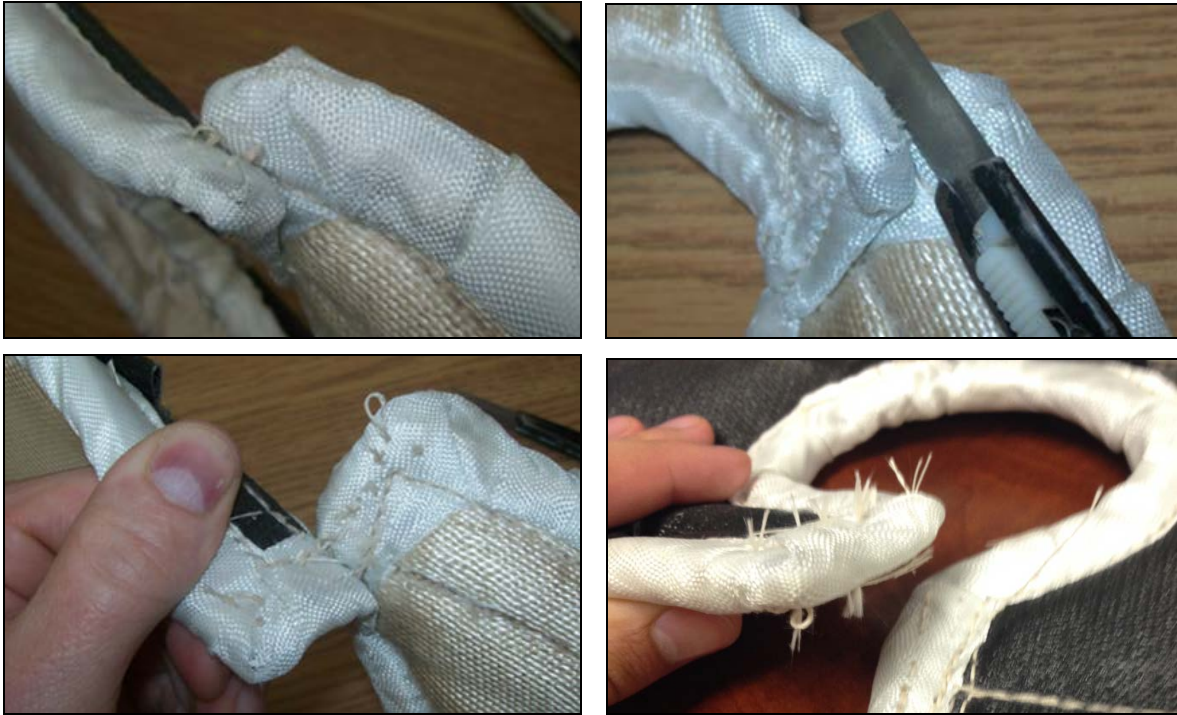
Some early production wraps are sewn in a way that they don't have the slit shown in (C) Figure 2. To use these early production wraps, unsewn them with a sharp knife as shown in the images below.

Do not disconnect the AHI Fuel Nozzle to install the Wrap.
