Title: Step-based Diagnostics for SPN 5542 FMI 15

Applies To: EPA 2010 MaxxForce 11, 13 Engines

Diagnostic procedure for fault code SPN 5542 FMI 15 (low pressure turbo outlet pressure too high / TC1TOP above desired)

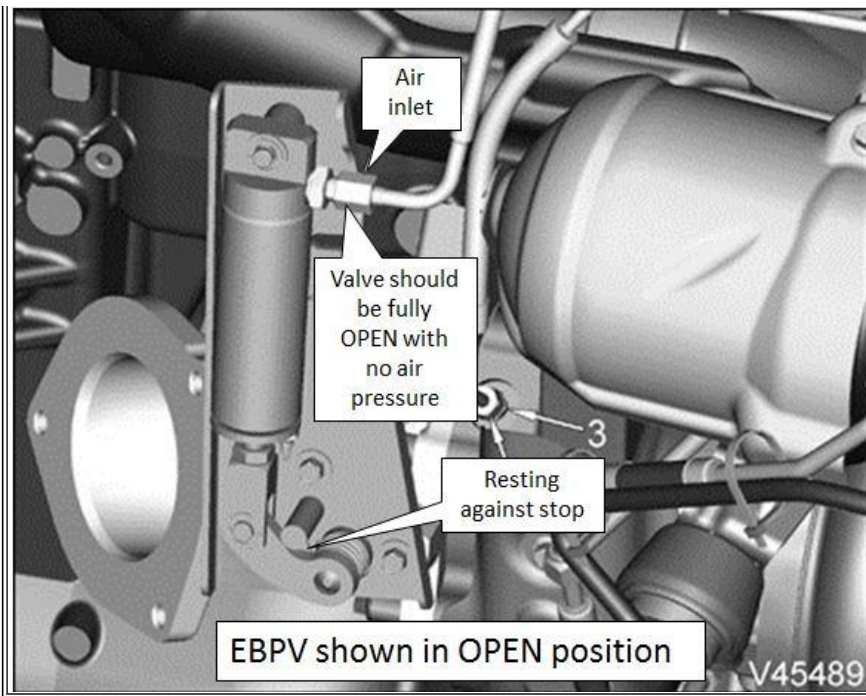
Step	Action	Decision
4	EBPV actuator inspection <ul style="list-style-type: none"> • Key OFF • Inspect EBPV actuator and linkage • Figure 1 Is the EBPV OPEN (air cylinder NOT extended)?	Yes, Open: Go to step 6 No, closed or partially closed: Go to step 5

Figure 1: EBPV in OPEN position (key OFF)

Step	Action	Decision
5	EBPV actuator closed or partially closed <ul style="list-style-type: none"> • Key OFF • Remove air inlet line from EBPV actuator cylinder • Figure 1 Does air escape as air inlet connection is removed?	Yes, ACV has failed (air is being supplied to the EPBV with key off)
		No, EBPV is stuck or seized. Replace EBPV assembly
