Countries: Document ID: IK1201270
 Availability: Revision: 1
 Major System: ENGINES Created: 2/25/2015
 Current Language: English Last Modified: 6/4/2015
 Other Languages: NONE Author: Alex Buzgau
 Viewed: 61

Title: Interstage Cooler Interference With Valve Cover Sound Shield Mounting Bolts

Applies To: EPA 2013 HD-OBD and later DT/9/10 and N9/N10

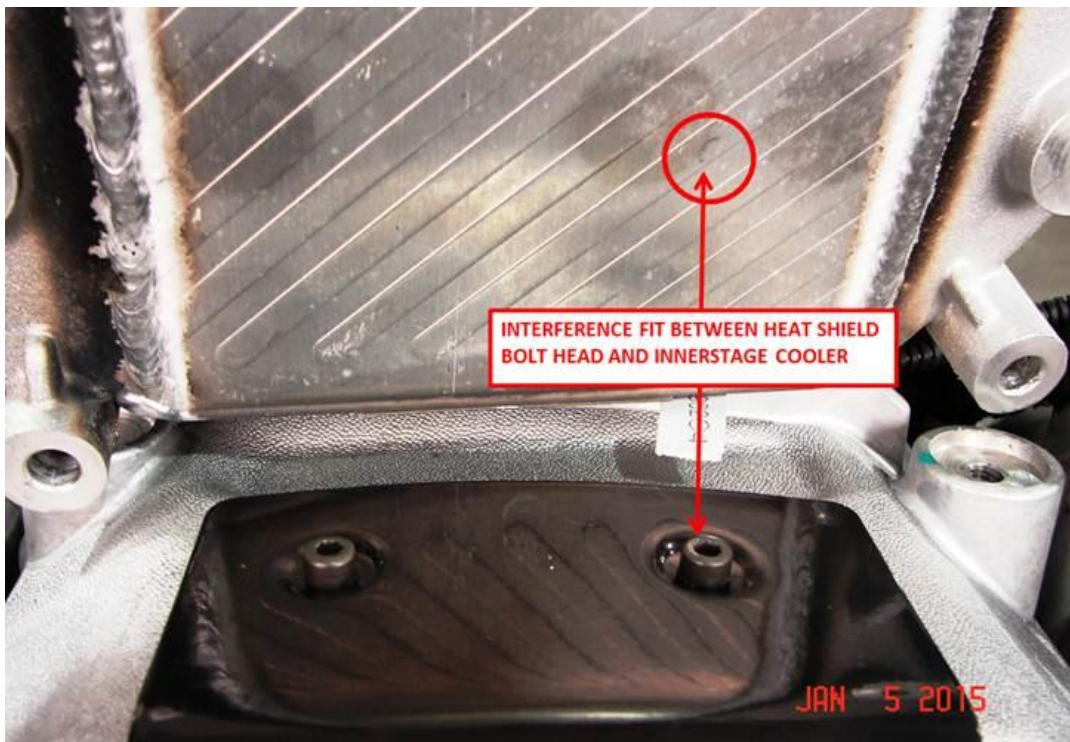
If contact between the bottom panel of the interstage cooler and the valve cover sound shield mounting bolt is observed, the current socket head screw could cause interference issues between itself and the interstage cooler.

To remedy this, the socket head screw must be replaced with a button head screw, which will provide an additional 2.25mm of clearance. Additionally, if the interstage cooler is punctured due to the interference then it also must be changed.

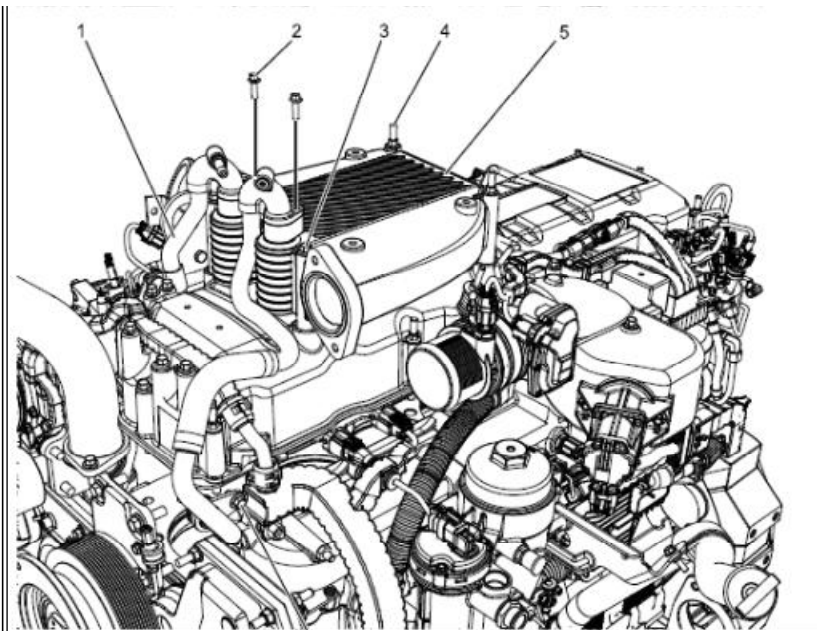
Figure 1: Interstage Cooler

- 1. ISC coolant supply tube
- 2. M6 x 20 bolt (2)
- 3. M8 x 110 bolt (2)
- 4. M8 x 110 stud bolt (2)
- 5. Interstage cooler (ISC)
- 6. M8 x 16 bolt

- 1. Drain engine coolant using KL5007NAV - Coolant Management Tool
- 2. Remove M8 x 16 ISC return tube bolt from cylinder head.
- 3. Remove two M6 x 20 ISC bolts from ISC.
- 4. Remove ISC coolant return tube.
- 5. Squeeze white plastic ISC coolant supply tube retainer and pull up on ISC coolant supply tube to disconnect from EGR coolant supply tube.
- 6. Remove ISC coolant supply tube.
- 7. Remove two M8 x 100 bolts and two M8 x 110 stud ISC bolts from valve cover.
- 8. Lift up ISC to remove from turbocharger inlet elbow.

- 1. Perform removal procedure in reverse.
