Document ID: IK1600217
Revision: 0
Created: 6/9/2015
Last Modified: 6/15/2015
Author: Alex Buzgau

Title: ProStar Grille/Bug Screen Rubbing Against A/C Condenser

Applies To: ProStar with Truck Build dates between 9/28/2009 and 10/1/2014

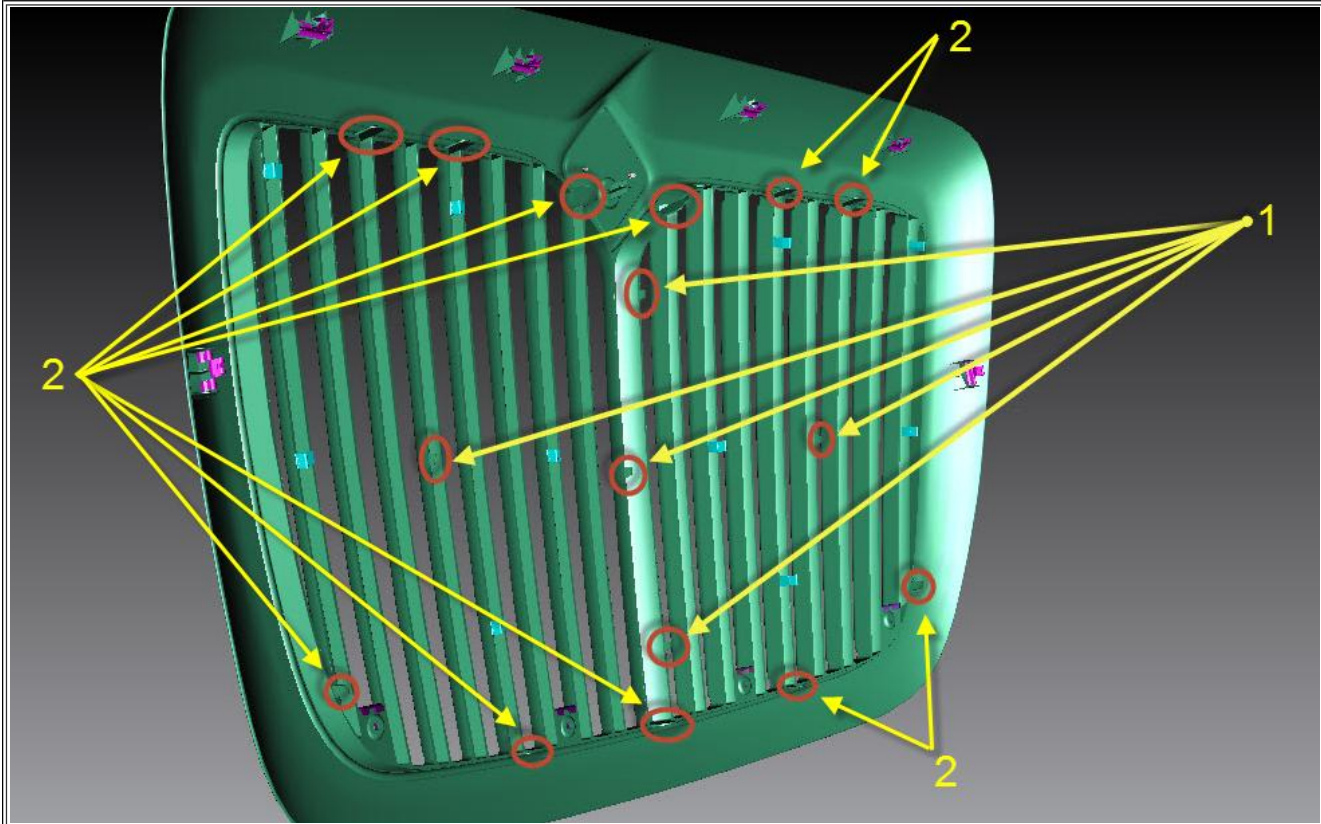
Figure 1: Grille with clip callout

The mounting clips on the ProStar bug screen can fall off and, in some cases, cause damage to the A/C condenser (bug screen contact during high winds and/or highway use). Additional clips should be added to the grille, in the specified locations, and the bug screen should be replaced as necessary.

- Item 1: Bug screen tabs
- Item 2: Chroming tabs

1. Add additional clips to the 5 mounting tabs with missing clips (see Figure 1 showing clip locations). Replace bug screen if bent or broken.
2. If the A/C condenser is damaged/punctured and it causes the A/C system to be inoperable, follow instructions for removal/replacement in the **9900, PayStar, ProStar, TranStar, WorkStar Heavy Duty (HD) Radiator / Cooling System Service Manual** ([0000628059](#)).
