**Document ID:** IK1200163

**Title:** Updated I6 EVRT/VGT Diagnostics Check Sheet and Turbocharger Repair Procedures for engines that exhibit DTC 353 / 354

**Applies To:** 2004- 2006 MY EGR DT 466 and 570 with EVRT/VGT Turbos with ESN 2,000,001 - ESN 3,000,000

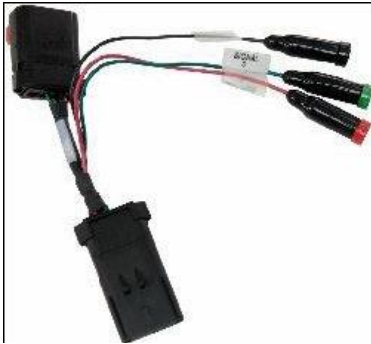
1. Connect the turbocharger breakout harness between the engine harness and the turbocharger actuator pigtail.

**Note:** The male/female connector has an additional retention locking feature that must be disengaged prior to separating the male/female connectors. This slide locking tab may be coated with paint that will be required to be scrapped off to ease disassembly.

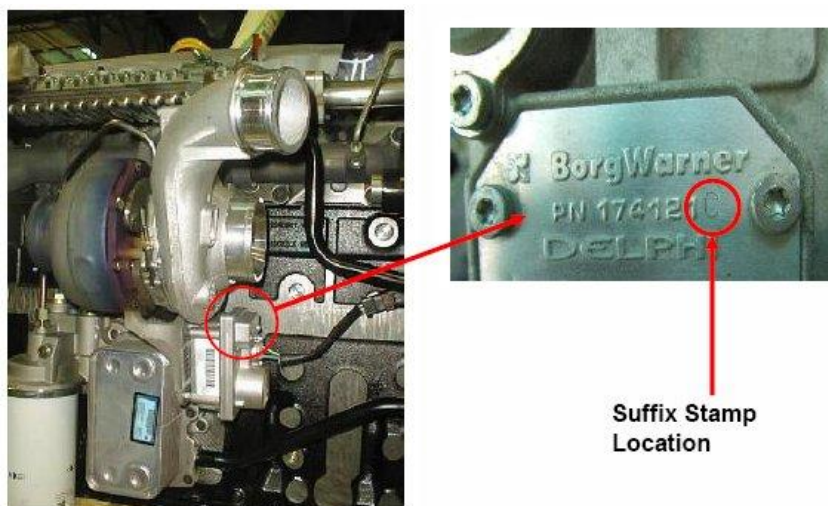
1. Locate the name plate stamp located on the actuator body.

**NOTE: This only applies to original factory installed Turbo chargers.**

2. Locate and identify the Suffix Stamp next to the Borg Warner Actuator Part Number embossed on the name plate. The Suffix Stamp will be a letter designation, but also maybe blank and not have a Suffix stamp letter.

**Decision Step 4A:** If it does not have Suffix stamp next to the part number, replace the actuator with Actuator Service Kit P/N 1847620C91.

**Decision Step 4B:** If the Suffix stamp next to the part number is A, B, C or D, replace the actuator with Actuator Service Kit P/N 1847620C91.

**Decision Step 4C:** If the Suffix stamp next to the part number is E, go to Step 5 Check the EBP Sensor Part Number.

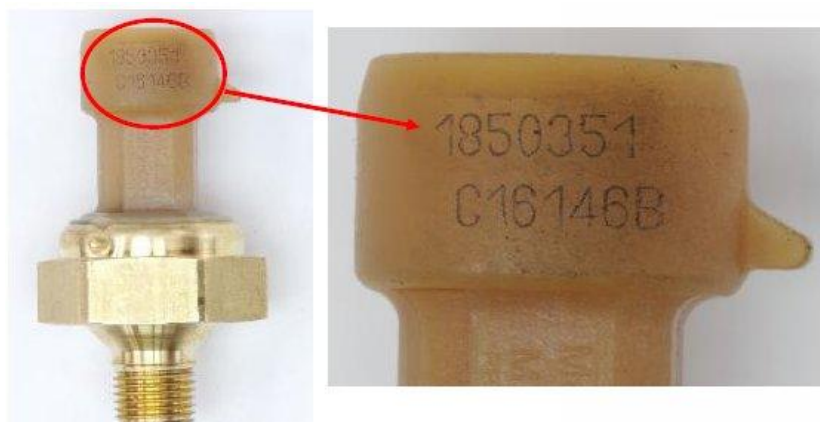
1. Locate the Exhaust Backpressure Sensor (EBP) located at the right front corner of the engine just above the alternator.
2. Locate and check the EBP part number printed on the plastic portion of the sensor body.

The printed part number will appear on 2 lines of the sensor body. The seven digit part number will be on the first line, and the second line will start with the part number suffix (ex. C1).

**Decision Step 5A:** If the EBP Sensor is not part number 1850351C1, replace the sensor.

**Decision Step 5B:** If the EBP Sensor is part number 1850351C1, The sensor does not need replaced unless you suspect EBP sensor is out of range. perform the EBP diagnostics steps in the Engine Diagnostic Manual [EGES 270-1 EBP Sensor](#) to validate the EBP sensor.

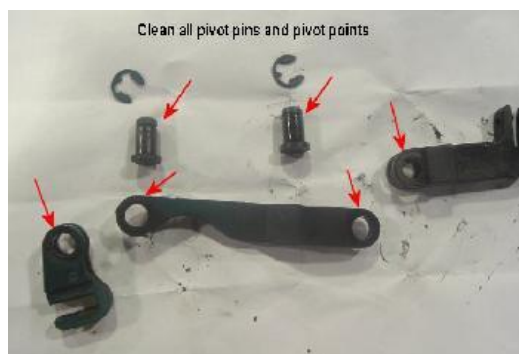
1. Remove the E clips from both of the fork lever pins and remove the pins.
2. Using emery cloth or a soft wire wheel, clean the inside of both fork levers, the ends of the intermediate linkage on both sides, and the fork lever pins

**Decision Step A:** If the linkages and pins are excessively worn (steps or elongated holes), replace the linkage.

**Decision Step B:** If the linkages and pins are not excessively worn, continue repair the linkage.

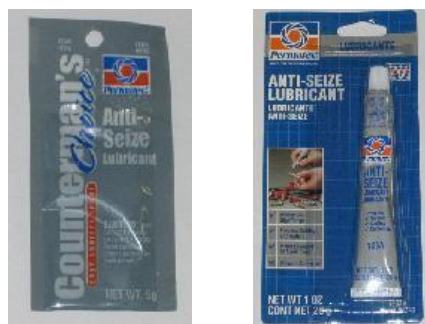
PN 1870706C1  
5 Grams

Retail Equivalent  
28 Grams

3. Apply anti-seize compound to all points of contact on the fork levers, pins, and the linkage using 1870706C1 Lubricant or commercially available equivalent.
