**Document ID:** IK1200969

**Title:** 2010+ IBB ETV (Engine Throttle Valve) - Diagnostics

**Applies To:** 2010 - Current Maxxforce 11/13 & N13 Engines

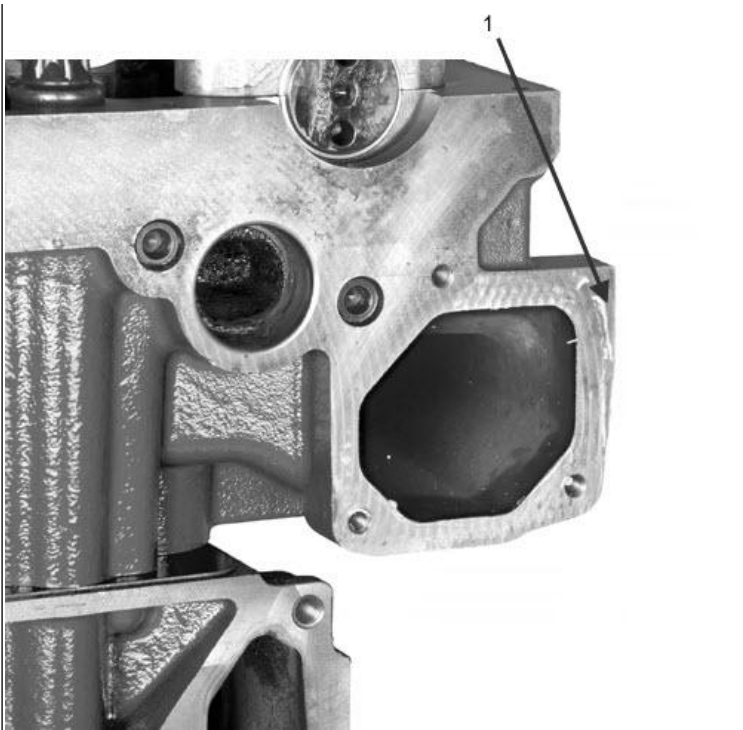
**Figure 1: Cylinder Head Intake Manifold**

The "old" seal between the Engine throttle duct and cylinder head is RTV; that is, Wacker 442, Loctite® 5900 Sealant, or equivalent. This should no longer be used, and the Intake Throttle Gasket noted above, should be used instead.

Use a scraper to remove the RTV application on the cylinder head and engine throttle valve (if not done already), and install the engine throttle valve gasket with the air intake throttle duct.
