**Title:** Pinched Coolant Line Resulting in 2630:16 Fault

**Applies To:** DuraStar with 2013 Emissions MaxxForce DT/9/10

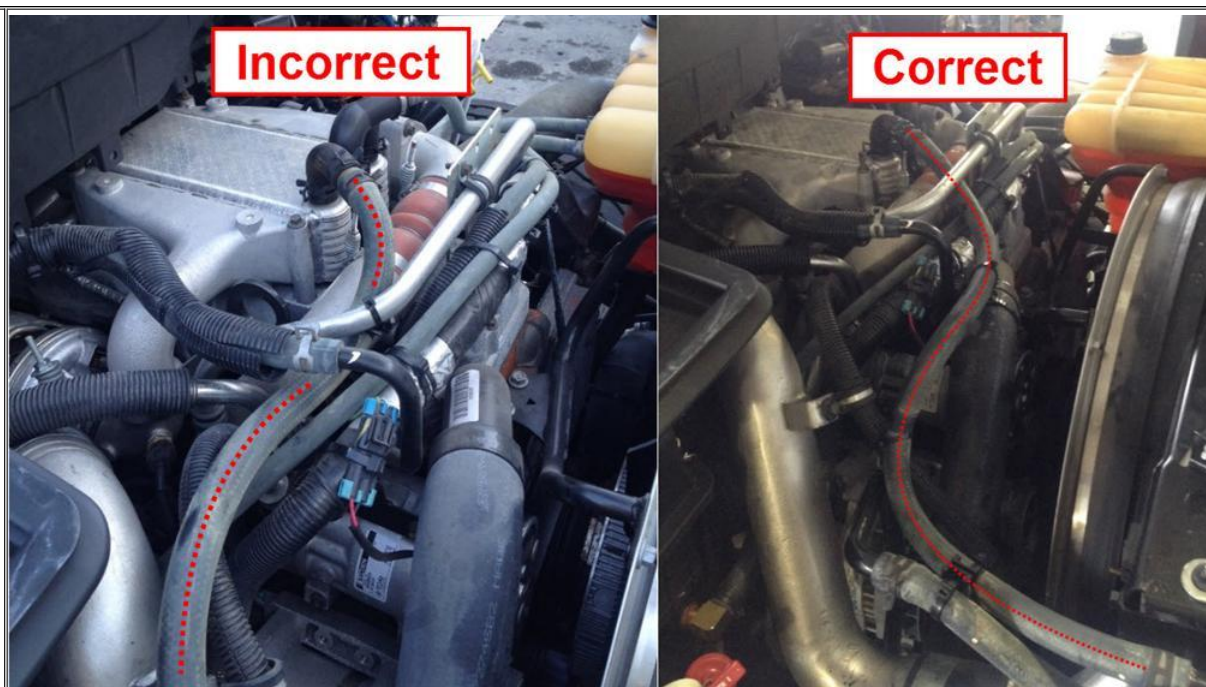
**Figure # 1**

- The image above shows the correct routing for the coolant hose

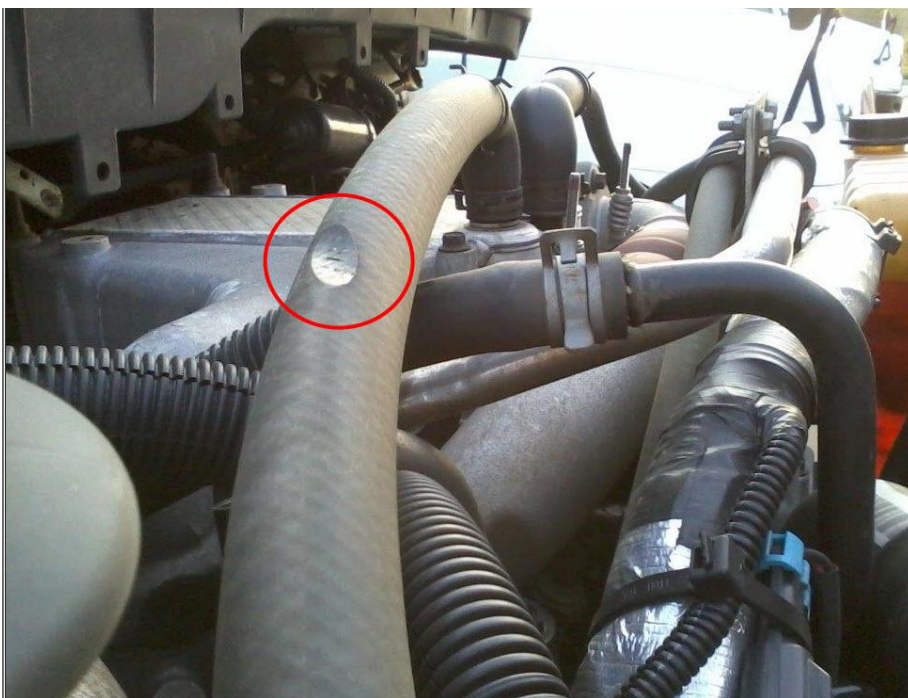
**Figure # 2**

- Another indicator of incorrect routing is rub marks on the hose.
- If excessive rubbing is found then the hose should be replaced to avoid a rupture.
