**Document ID:** IK1600218

**Major System:** CAB / SLEEPER / HOOD

**Title:** Seat occupant sensor

**Applies To:** Terrastar, Durastar, ambulance, medic rescue, 16HCK or 16HCL

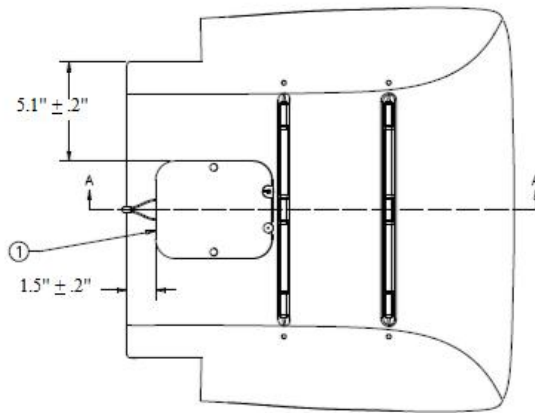
**Figure #1:One sensor cushion**

| Step | Action | Decision |
|---|---|---|
| 3 | <b>DIAGNOSTIC:</b><br>Inspect the approximate location of the sensor. This can be done without removing the cushion cover. Is the sensor in the correct location? See figure #1, 2 and 3 for sensor locations for the different cushions. | <b>Yes.</b><br>Go to the applicable diagnostic guide for the system that is installed. |
