Service Bulletin

Subject: Information On Identifying Duramax™ Diesel Overpower Engine Breakdown or Non-Function Due to Aftermarket Power-Up Devices vs. Non Overpower Engine Non-Function of Pistons, Cylinders, Valvetrain Components, DTC P003A or P111D Set

Models: 2001-2016 Chevrolet Silverado
2003-2009 Chevrolet Kodiak
2006-2016 Chevrolet Express
2001-2016 GMC Sierra
2003-2009 GMC TopKick
2006-2016 GMC Savana
Equipped With Duramax™ Turbocharged Diesel Engine RPO LB7, LBZ, LLY, LML, LMM, or LGH

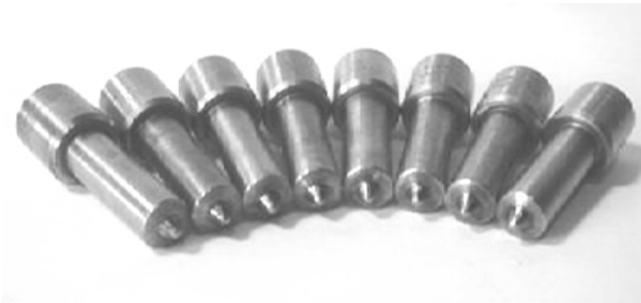
Aftermarket companies have developed a replacement performance/economy fuel injector nozzle. Refer to above illustration. The performance/economy fuel injector nozzles replace the OEM fuel injector nozzles. The aftermarket companies claim increased horsepower, improved fuel atomization, lower exhaust gas temperatures and increase fuel economy. This may cause additional fuel related driveability concerns and may cause internal engine damage to the pistons and fuel injector nozzles.

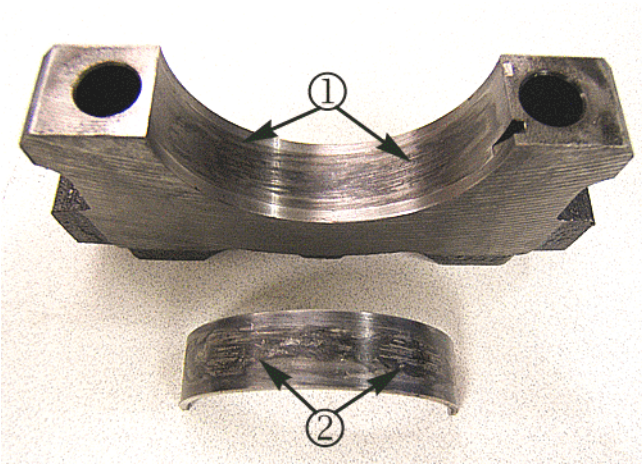
- Signs of bearing fretting will also be noticed on the connecting rod and main bearing caps. Refer to the above illustration for fretting of main bearing cap 1 and back side of connection rod bearing 2.

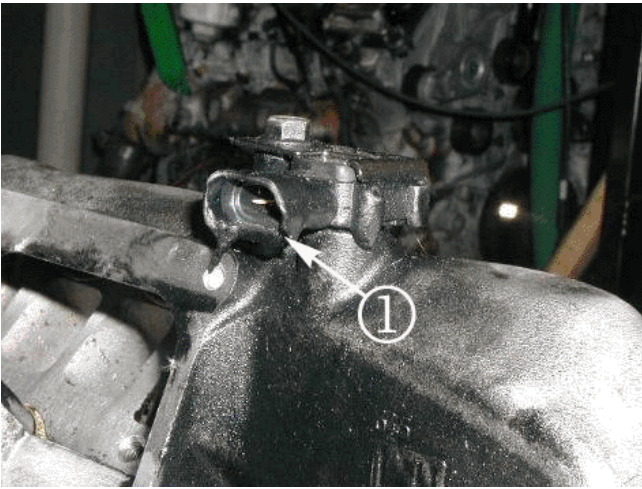
- Excessive heat in engine compartment caused by overpower device. Refer to above illustration (1).

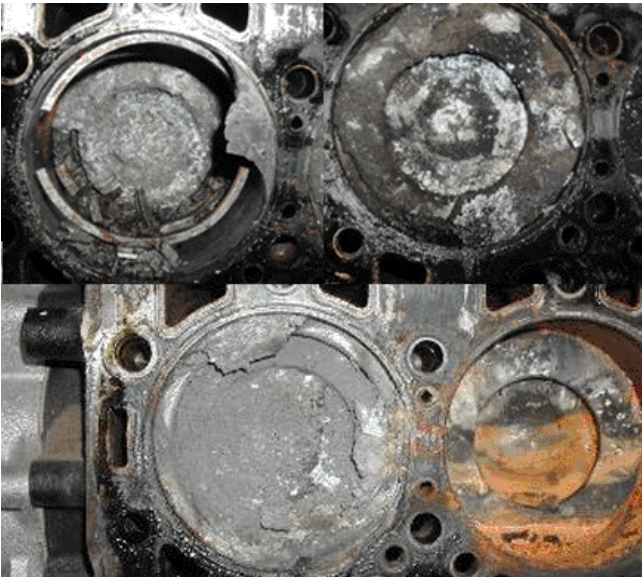
Overheat can be caused by a loss of coolant or a general cooling system failure. Some of the indicators of overheat are:

- Melted pistons.
- Head gasket breakdown or non-function.
- Warped cylinder heads.
- Crankshaft and connecting rod discolored.

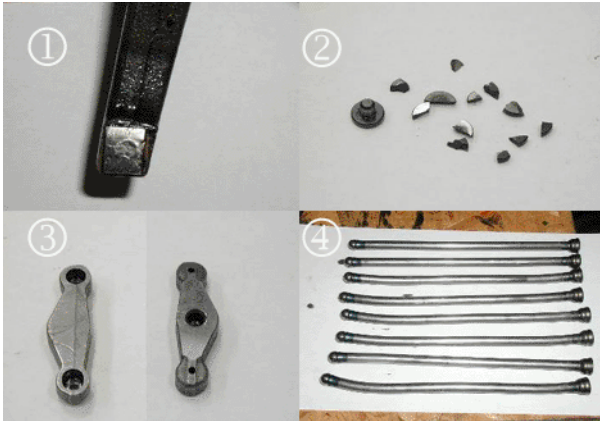
- Valve train damage.
- Pushrods that are bent (4).
- Broken valve bridge buttons after cylinder head removal (2).
 - Rocker arm tip damage (1).
 - Dry or rusted cylinders from the use of ether, propane or nitrous oxide.

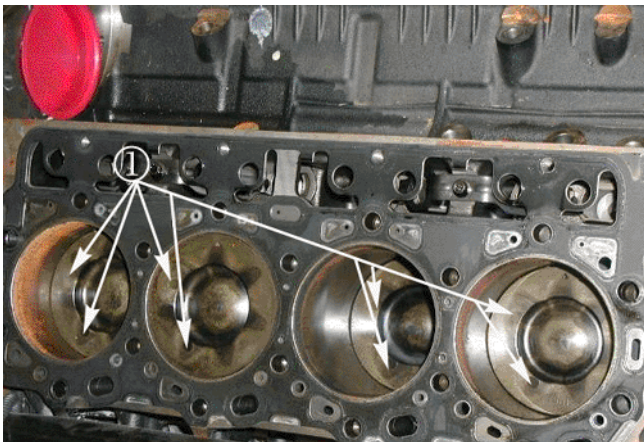
- Piston to valve contact.
- Cam gear pin shear.

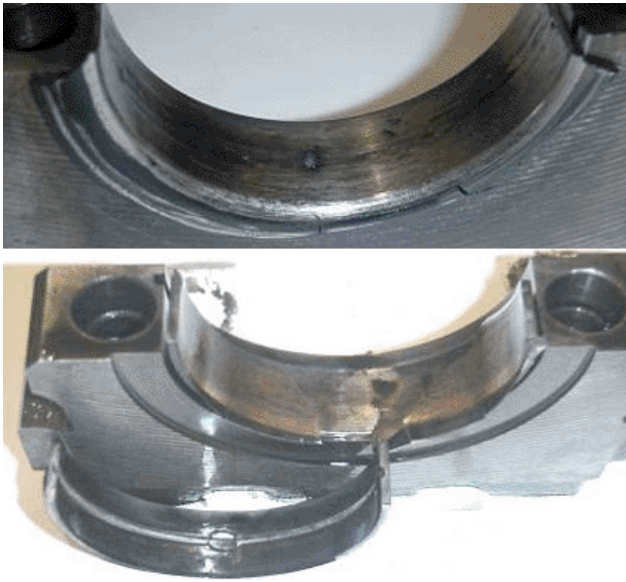
Lack of lubrication causes rapid bearing wear or bearing to seize.

Bearing failure. Spun main bearings.

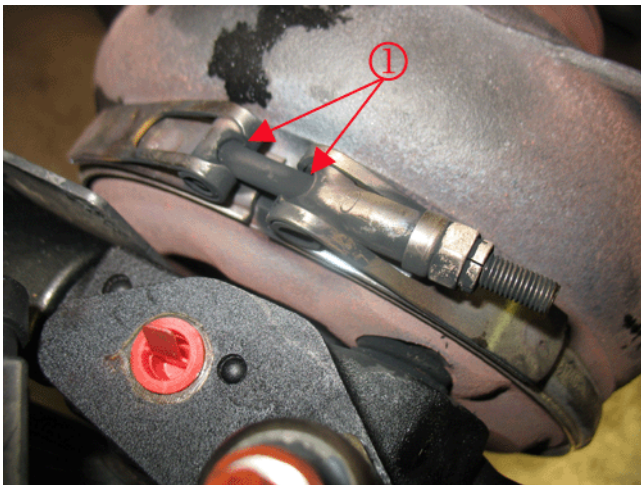
General Motors has identified a turbocharger (TC) failure mode involving Power-Up Kits that causes soot leakage and DTC P003A to be set. The Power-Up Kits create an over temperature condition from the increased exhaust gas temperatures that results in a permanent and excessive turbine housing distortion at the TC case halves.

1. A technician may observe one or more of the following conditions:
 - DTC P003A being set as Current or in History.
 - An unusual odor emanating from the TC due to an overtemperature condition.
 - Soot leaking and accumulating at the V-band clamp that secures the TC case halves together.
 - Limited or unresponsive travel when Commanding the TC Vane Pos. Ctrl. Solenoid ON and OFF with a scan tool.

2. If DTC P003A is found as Current or in History, **OR** there is evidence of soot leakage (1) in the area of the V-band clamp (1), then technicians **MUST** verify if the engine control module (ECM) has a Power-Up Kit aftermarket calibration installed or an aftermarket hardware device has been installed. Refer to the latest version of Corporate Bulletin Number 08-06-04-006 as well as 14-016-04-003 for the calibration verification information and procedures.
