# Service Bulletin

**Subject:** Service StabiliTrak Message Displayed, DTC C0196-5A Set in Electronic Brake Control Module (EBCM)

**Models:** 2015-2016 Cadillac Escalade Models  
2014 Chevrolet Silverado 1500  
2015-2016 Chevrolet Silverado, Suburban, Tahoe  
2014 GMC Sierra 1500  
2015-2016 GMC Sierra, Yukon Models

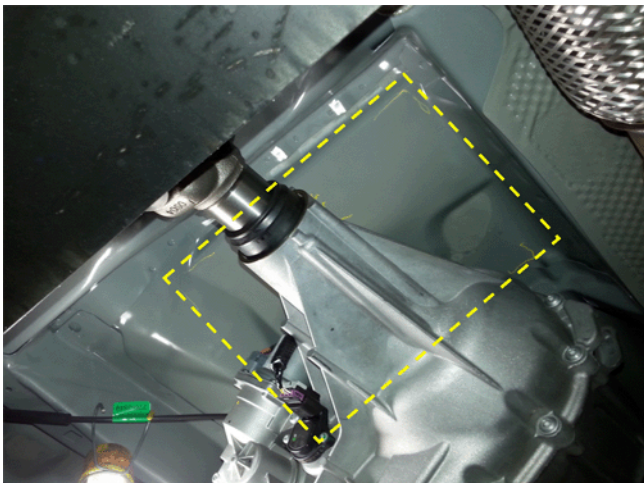
2. Locate area shown above transmission and transfer case, if equipped.
3. Ensure the area is free of any debris by cleaning the area with wax and grease remover or equivalent. Ensure area is dry.
4. Mark the transmission tunnel as noted.
