Bulletin No.: 15-NA-004

Service Bulletin

Subject: Intermittent No Crank, Radio, HVAC Inoperative, Erratic Operation of I/P Cluster, DTCs U0140, U0155,

Brand:	Model:	Model Year:		VIN:		Engine:	Transmission:
		from	to	from	to		
GMC	Acadia	2013	2016			All	All

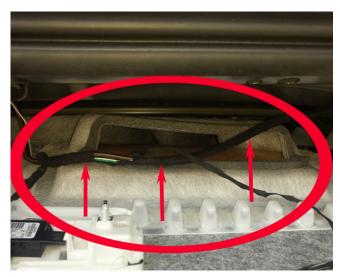
This condition may be caused when the low speed LAN wire to the remote control door lock receiver (RCDLR) becomes pinched between the plastic rear HVAC headliner duct and the roof.

3. Pull the headliner down, repair the necessary portion of the harness. Refer to Wiring Repairs in SI.
