# Service Bulletin

**Subject:** Water Present on Front Passenger Floor, A/C Drain Hose Not Positioned Correctly

**Models:** 2014-2016 Cadillac ELR  
2011-2016 Chevrolet Volt

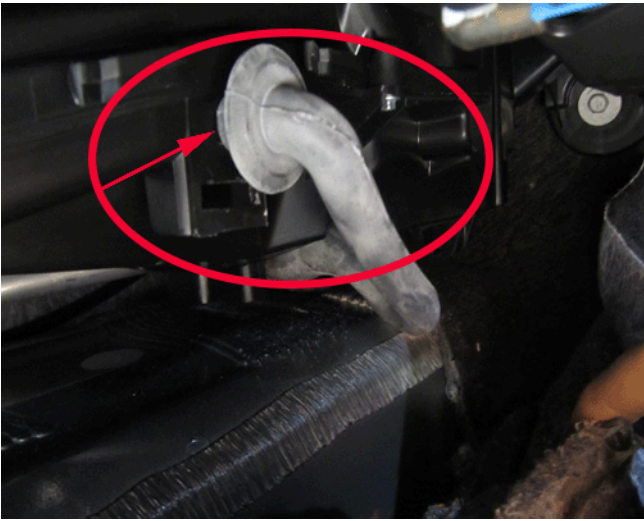
**Note:** Shown in the illustration above is where the plant temporary installs the A/C hose during Instrument panel installment. Do not drill out the temporary holder for any reason.

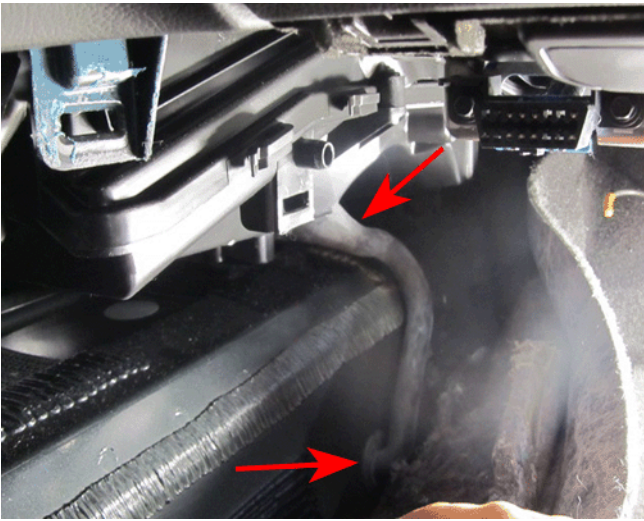
**Note:** Shown in the illustration above is the A/C hose properly installed onto the correct drain port.

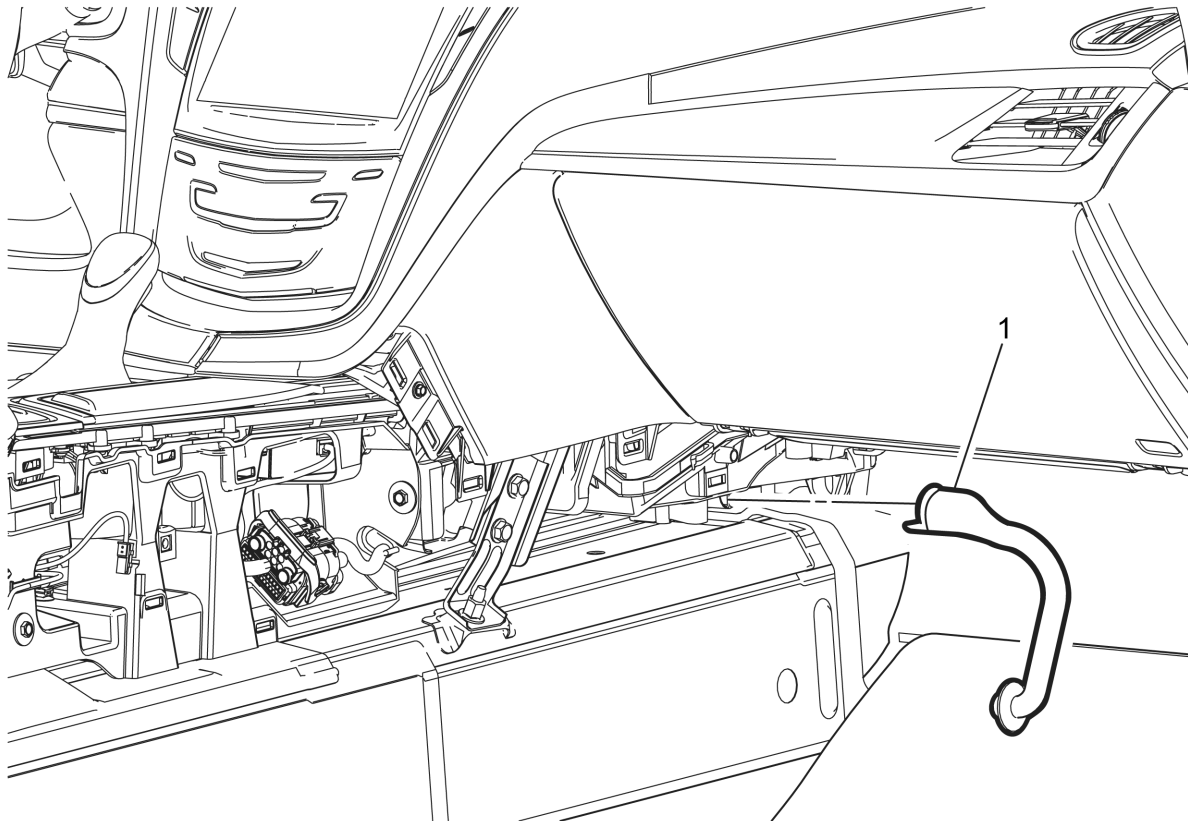
This condition may be caused by the air conditioning evaporator and blower module drain hose not being fully seated or has become disconnected or improperly installed during assembly.

3. Fully seat or reinstall the A/C drain hose (1).
4. Reinstall the right front floor console extension panel. Refer to Front Floor Console Extension Panel Replacement - Right Side in SI.
5. Reinstall the front passenger carpet. Refer to the Front Floor Panel Carpet Replacement — Right Side in SI.
