Service Bulletin

Subject: Rear Fascia Retainment Concern Below Tail Lamp

Brand:	Model:	Model Year:		VIN:		Engine:	Transmission:
		from	to	from	to		
Chevrolet	SS	2015	2015			All	All

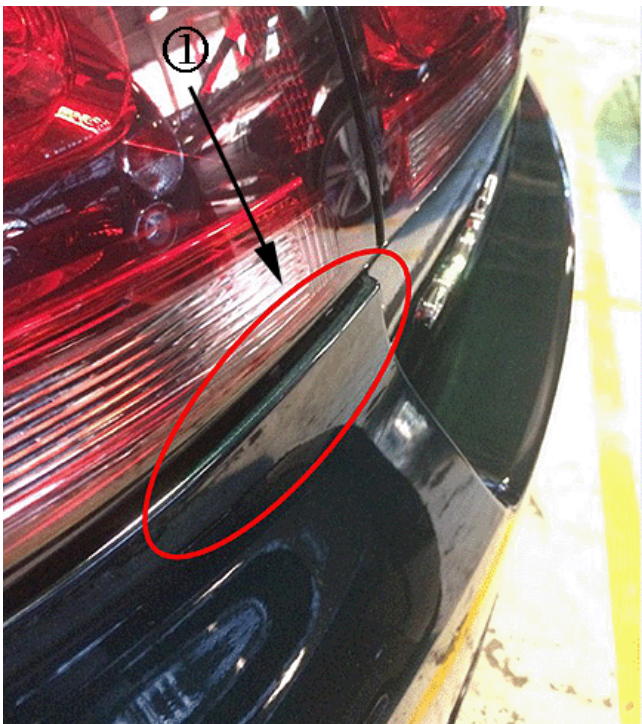
Condition	Some customers may comment that the fascia sticks out below the tail lamp.
Cause	This may be caused by poor retention of the fascia in the tail lamp bracket.
Production Solution (Optional and additional information)	The bracket is being tuned to improve retention.
