# Service Bulletin

**Subject:** Front Side Door Armrest Cover Trim Squeak Noise

Brand:	Model:	Model Year:		VIN:		Engine:	Transmission:
		from	to	from	to		
Chevrolet	Silverado 1500	2014	2016			All	All
GMC	Sierra 1500	2014	2016			All	All
Chevrolet	Silverado 2500, 3500	2015	2016			All	All
GMC	Sierra 2500, 3500	2015	2016			All	All

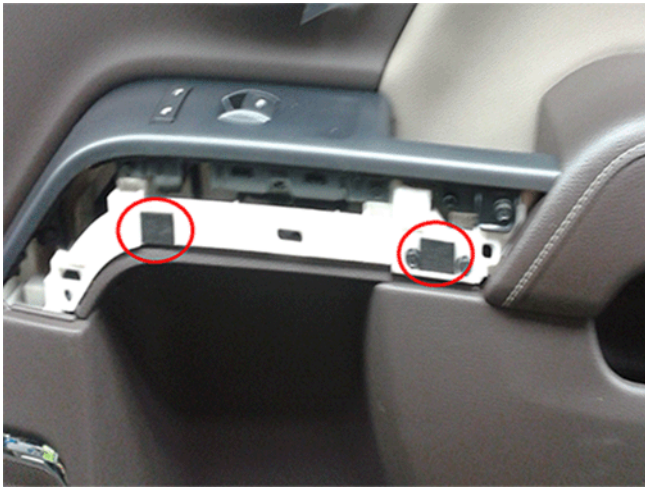
<b>Condition</b>	Some customers may comment on hearing a squeak noise from the driver or passenger front door armrest area.
<b>Cause</b>	The cause of the condition may be a tight interface between the surfaces of the front side door armrest cover trim plate and the door panel.
<b>Additional Options</b>	Equipped with Window - Power Operated, All Doors (RPO A31)

**Note:** The passenger side is shown in the graphic above; the driver side is shown below.

Verify the condition and apply BSR tape to the door trim panel on the affected side. The tape will be applied to partially cover two of the slotted openings in the plastic armrest bracket at the locations shown above.

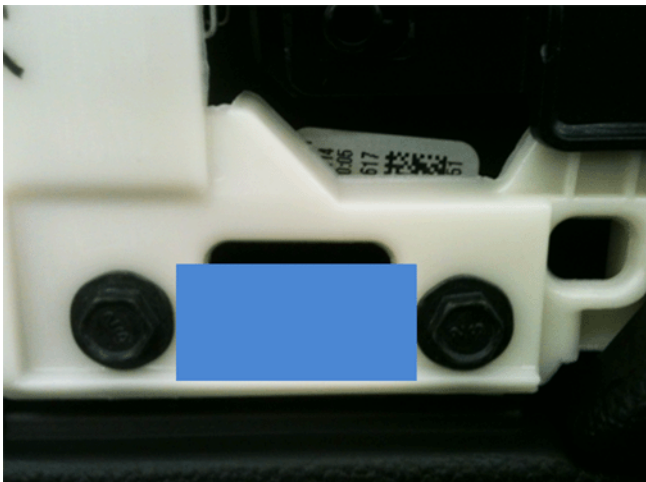
**Note:** As shown in the example above, the intent is to cover only 3/4 of the lower portion of the slotted opening.

2. Cut two pieces of \*Kent Automotive BRS tape, P/N KT13485 or equivalent, approximately 26 mm (1 in) in length.
