Service Bulletin

Subject: Alleged No Park or Vehicle Rolls in Park or Park Will Not Hold

Models: 2013-2015 Cadillac ATS, CTS Models, Escalade Models

Equipped with 6L45, 6L50, 6L80, 6L90 Automatic Transmission (RPOs MYA, MYB, MYC, MYD)

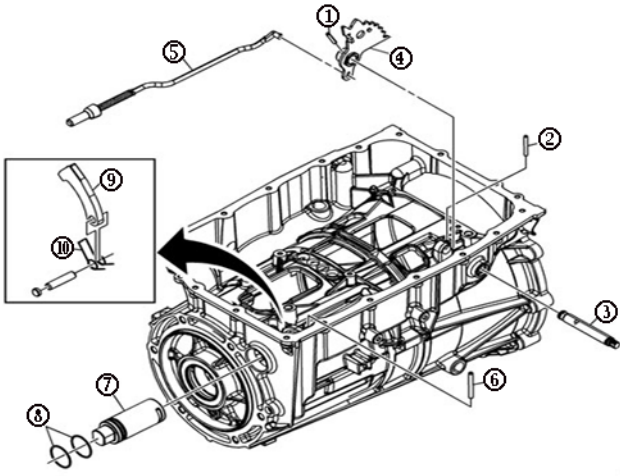
- Inspect the shift cable for proper adjustment and attachment to the range selector lever.
- Remove the transmission oil pan and inspect for debris in the pan or obvious signs of damage.
- Inspect the manual shaft detent lever assembly (4) and park pawl actuator assembly (5) for damage.
- Inspect the park gear for damage or peening of the teeth.
- Inspect the park pawl (9) and park pawl spring (10) for damage.

Note: The park pawl (9) and park pawl spring (10) are not serviced separately. If they are found to be damaged, the case assembly must be replaced.

If no damage was found during the inspection and the cause of the alleged no Park condition was not found, replace the park pawl actuator assembly (5). Refer to the part numbers listed below.
