Service Bulletin

PRELIMINARY INFORMATION

Subject: Hood Flutter, Shake or Vibration at Highway Speeds or over Rough Road Conditions

Models: 2015-2016 Cadillac Escalade, Escalade ESV
2014 Chevrolet Silverado 1500
2015-2016 Chevrolet Silverado, Suburban, Tahoe
2014 GMC Sierra 1500
2015-2016 GMC Sierra, Yukon, Yukon XL

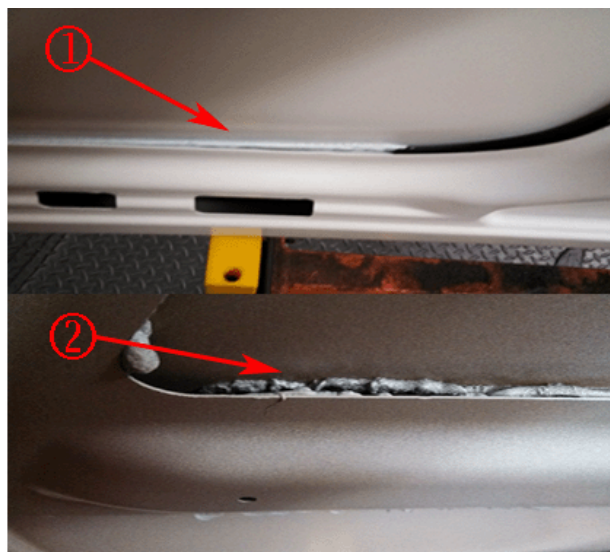
The inner and outer hood panels may not be sufficiently bonded together at all points. At highway speeds or over rough surfaces, the sheet metal may be able to flutter at some locations.

1. Separation
2. Gap/Void

Apply panel vibration control material between the inner and outer panels. The procedure below outlines the proper repair instructions. The accompanying illustrations show the most likely areas that may be the source of the fluttering.

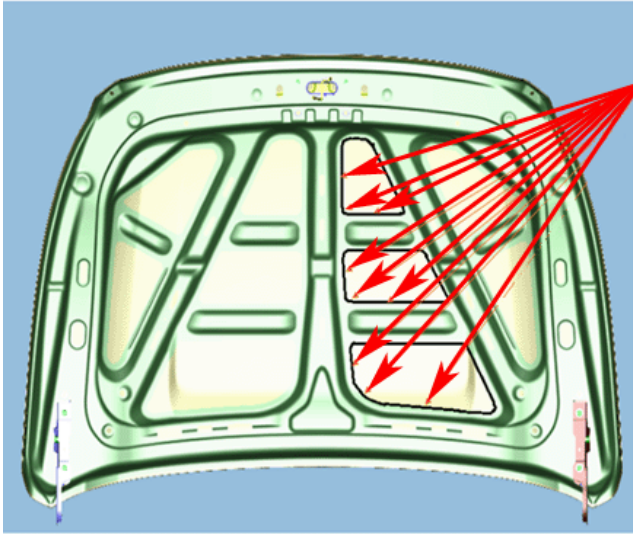
5. Refer to the picture above (GMC Yukon shown – others similar). In all cases you will be filling the void between the inner and the outer panels to prevent the metal fluttering. The arrows indicate the areas most likely to require additional bonding. Examine the underhood panel for signs of original factory shrinkage or insufficient application, similar to the pictures listed in the Condition/Concern section.
