Service Bulletin

Subject: Rear Turn Signal Socket Does Not Correctly Connect to Body Harness When Installing Accessory Tail Lamps and/or Replacing Rear Turn Signal Socket

| Brand: | Model: | Model Year: | | VIN: | | Engine: | Transmission: |
|---|---|---|---|---|---|---|---|
| Cadillac | SRX | 2015 | 2016 | | | All | All |

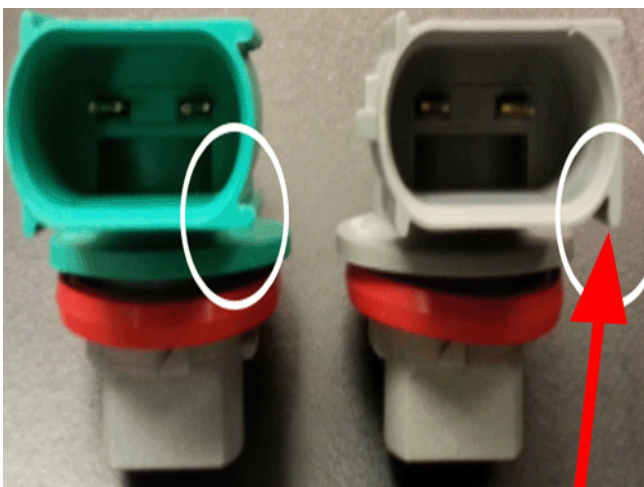
| Condition | Technicians may notice when replacing rear turn signal bulb sockets on SRX Sport models, or installing accessory clear lens tail lamp assemblies, that the turn signal socket may not correctly fit into the body harness connector. |

If you encounter a vehicle with the above concern, use a piece of sand paper or equivalent to sand the guide pin off to correctly fit the body harness.

Important: Do NOT replace the tail lamp assembly, body harness or body harness connector for this concern.
