Service Bulletin

Subject: Driver and/or Passenger Power Seat Height Stuck in the Full-up Position, Intermittent Inoperative Seat Adjustment or Not Lowering

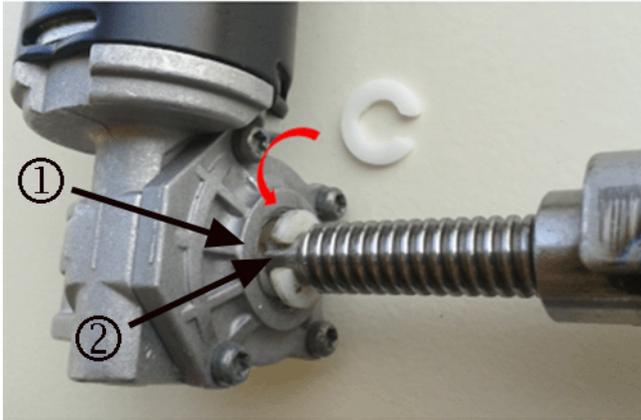
Involved Region or Country	North America and all N.A. Export Regions
Condition	Some customers may comment on the front power seat height adjustment (not the tilt function) being inoperative, not lowering or being stuck in the uppermost travel position. They may also comment that the up/down function works intermittently.
Cause	The cause of this condition may be manufacturing variation of the height adjuster motor casting interface to the spindle nut, while in the uppermost position.
Additional Options	Equipped with Power Adjustable Seats (RPO AG1, AG2, AMM, AKQ, ADS, AE8 or AH8)

To eliminate the manufacturing variation, add a split washer/retainer to the drive screw between the interface of the motor casting (1) to the spindle nut (2). The graphic above shows the height adjuster motor with the retainer added, and another sample retainer alongside the motor.
