Program Bulletin

CUSTOMER SATISFACTION PROGRAM

SUBJECT: Engine Harness Chafing On EGR Stud

MODELS: 2015 Chevrolet Silverado HD
2015 GMC Sierra HD
Equipped with the Duramax Diesel 6.6L Engine (RPO LML)

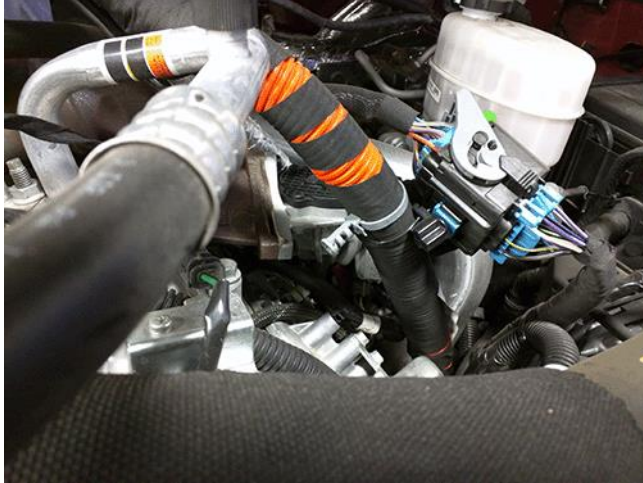
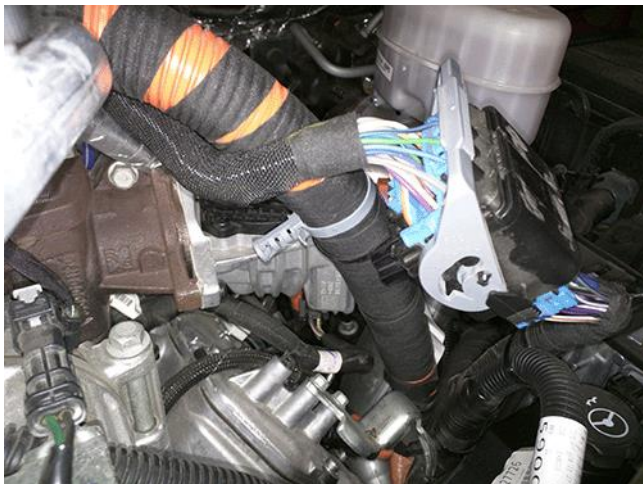
1. Open hood and install fender covers.
2. Inspect the main engine harness for any damage. If any damage is found, repair wire(s). Refer to *Wiring Repairs* in SI before proceeding to step 2.
