PREVOST

**WARRANTY
BULLETIN**

WB14-47B

DATE :	OCTOBER 2014	SECTION :	04 - Exhaust
EXPIRATION:	OCTOBER 2016		
SUBJECT :	UREA DOSING SYSTEM UPDATE - X AND H SERIES

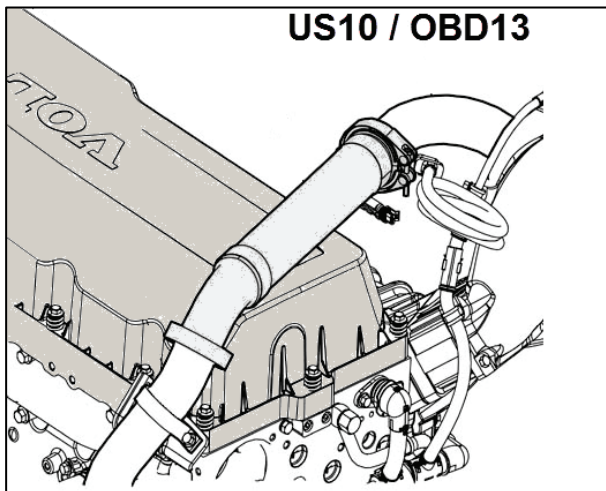
Figure 1 US10 / OBD13 Valve cover

US10 and OBD13 Vehicles

Update according to steps **A** and **B** below.

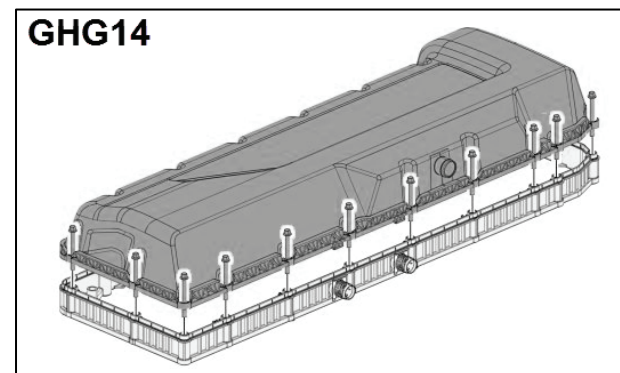
Figure 2 GHG14 valve cover

GHG14 engines have a "split" cover (Fig 2).

Update according to steps **A** et **B** below. And add a VECU update
