BOSCH HD10 ALTERNATOR CONNECTION INSPECTION

Prevost vehicles

On the vehicles affected by this bulletin, inspect the Bosch HD10 alternator connections.

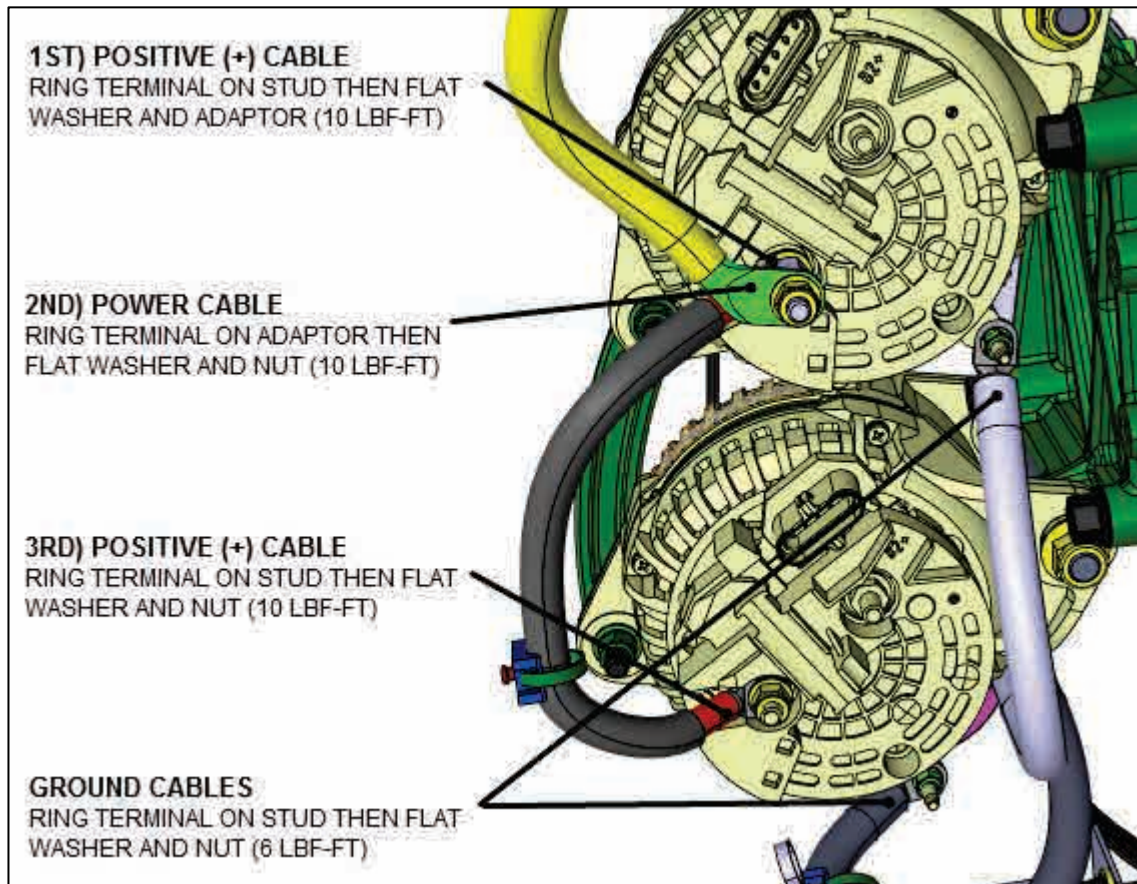
Figure 1

Upper and lower alternator torque reference, cable and hardware arrangement (Fig. 1).
