# PREVOST

## WARRANTY BULLETIN

### WB15-13

| SUBJECT : | IFS LEVEL VALVE CONTROL ROD POSSIBLE CONTACT | | |

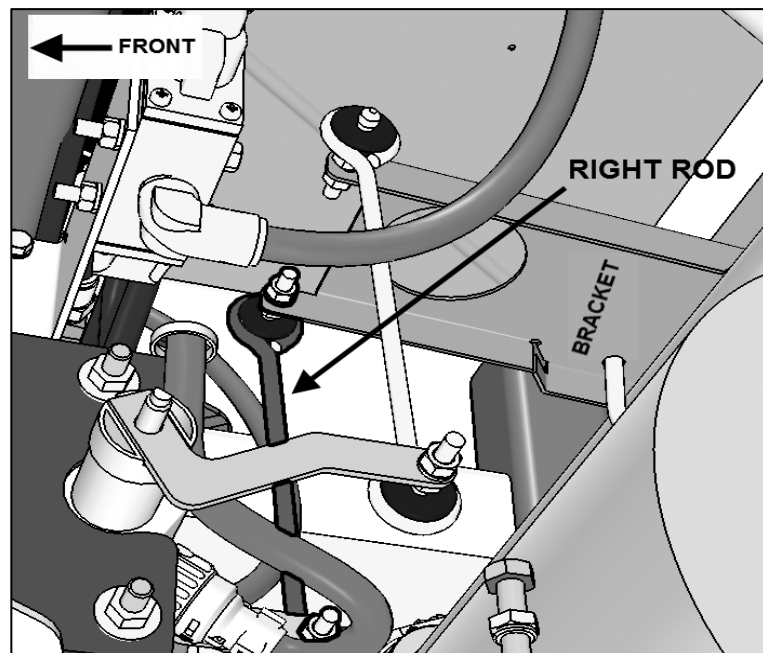
Figure 2

2. In the middle of the sway bar you will find a bracket clamped on the tube. The bracket supports two control rods (Fig. 2)

3. On the right hand side rod. (Fig.2) Unscrew the upper and lower mounting nuts.
4. Flip the rod over to the opposite side of the control lever and bracket tab above. (Arrow, Fig. 3)
5. Re-assemble hardware. (Fig.3)

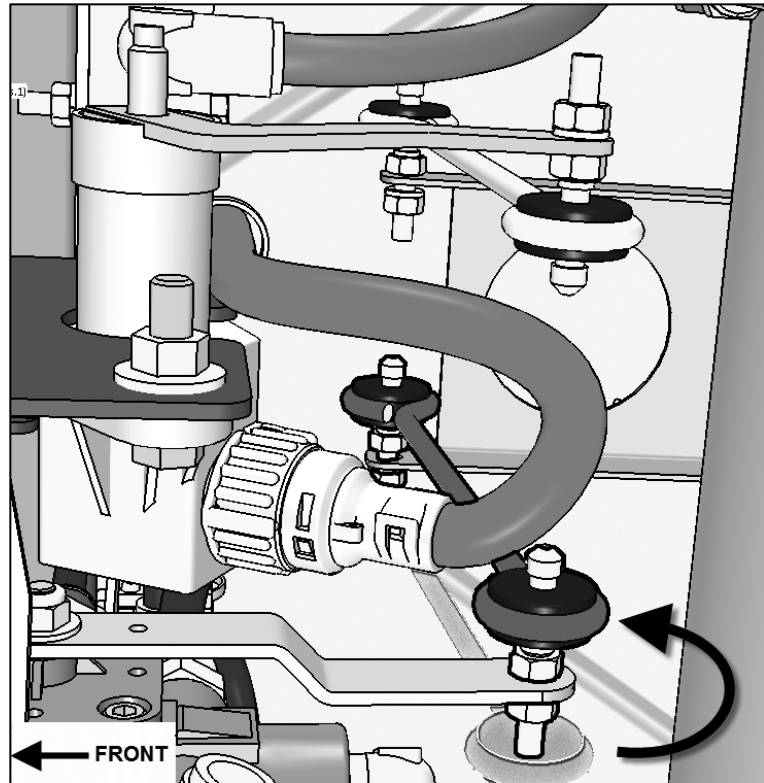
On the independent front suspension level valve linkage of the vehicles affected by this bulletin, a control rod may come in contact with an air reservoir outlet when vehicle rises from Low to High Buoy. As a result, the vehicle may be leveled higher in "Normal" position.

Figure 3 : Flip upper and lower connection of control rod.
