Vehicle Speed Sensor  
 VN, VAH, VHD

**FSB 386-007, Vehicle Speed Sensor**

(November 2014)

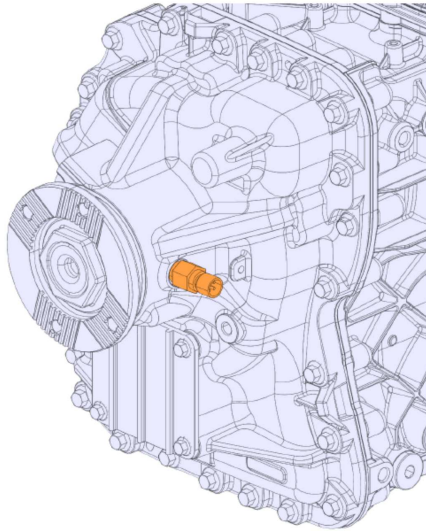
W3094986

- 4 Remove the VSS from the transmission.

**Note:** If sensor part number 3171490 is found to have been installed and needs to be replaced, this sensor is also replaced with 22387296.

**Note:** If a gasket or shim is present between the sensor and transmission discard it **DO NOT** reuse with new sensor.
