Turbocharger Outlet Pipe VN

FSB 252-031, Turbocharger Outlet Pipe

(September 2015)

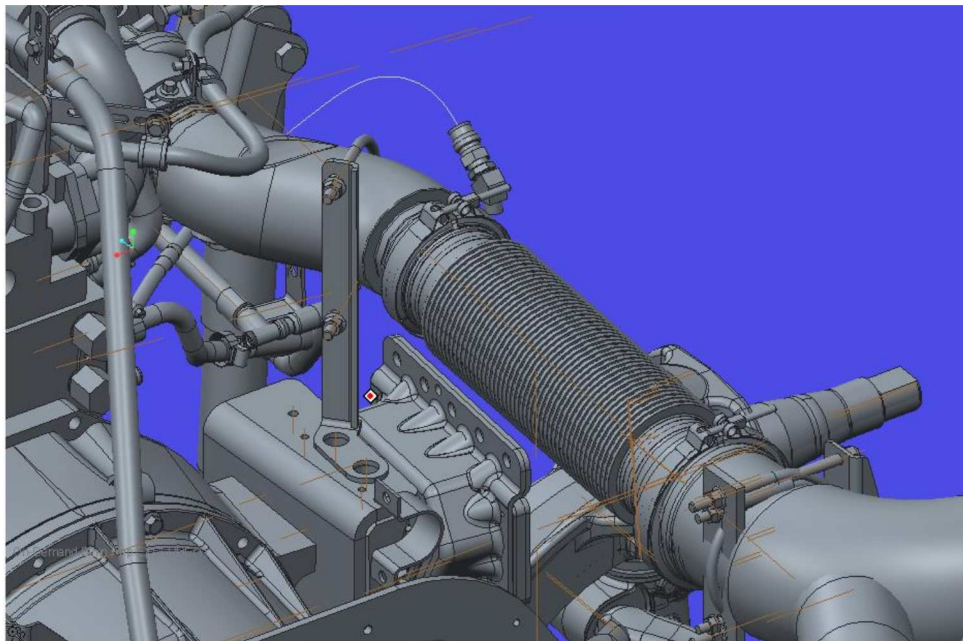
W2106127

Some Volvo vehicles equipped with Cummins ISL engine may have a cracked turbocharger outlet pipe. The crack develops at the flange to pipe weld area. There is a new support bracket to take load and vibration out of the joint area and eliminate future failures.
