# Service Bulletin

## PRELIMINARY INFORMATION

**Subject:** Cold Start Misfires

**Models:** 2015-2016 Cadillac Escalade  
2014-2016 Chevrolet Corvette  
2014-2016 Chevrolet Silverado 1500 Suburban, Tahoe  
2014-2016 GMC Sierra 1500 Yukon Yukon XL  
Built with engine RPO's 4.3L, 5.3L, 6.2L, L83, L86, LT1, LT4, LV3

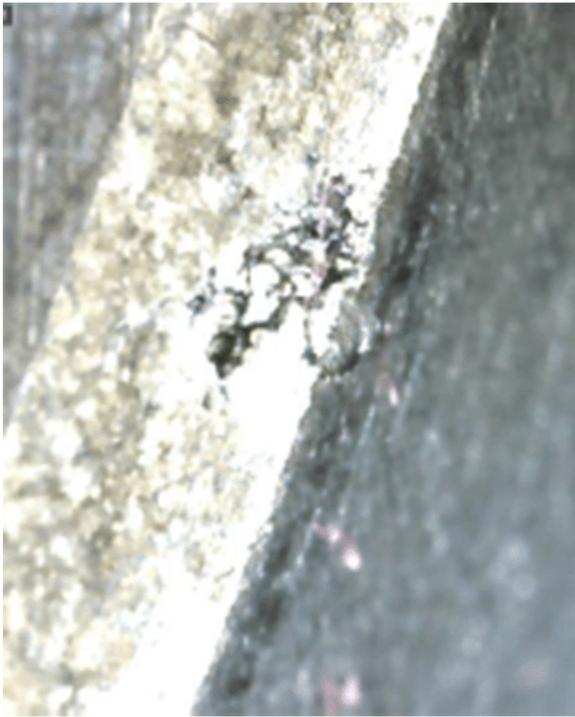
See pictures below for examples of deck pitting and actual porosity with leak path.

Small surface pock marks or pitting appearance on the deck surface is normal and engines should not be replaced for such appearance as they do not connect to coolant passages and cause a leak path that generate engine misfires.

During engine warranty analysis studies, engines are being replaced for small pitting in the deck face as described above, when the subject cylinder / piston is saturated with fuel and not coolant

Engine replaced for subject pitting conditions will be returned to the dealership as non defective.

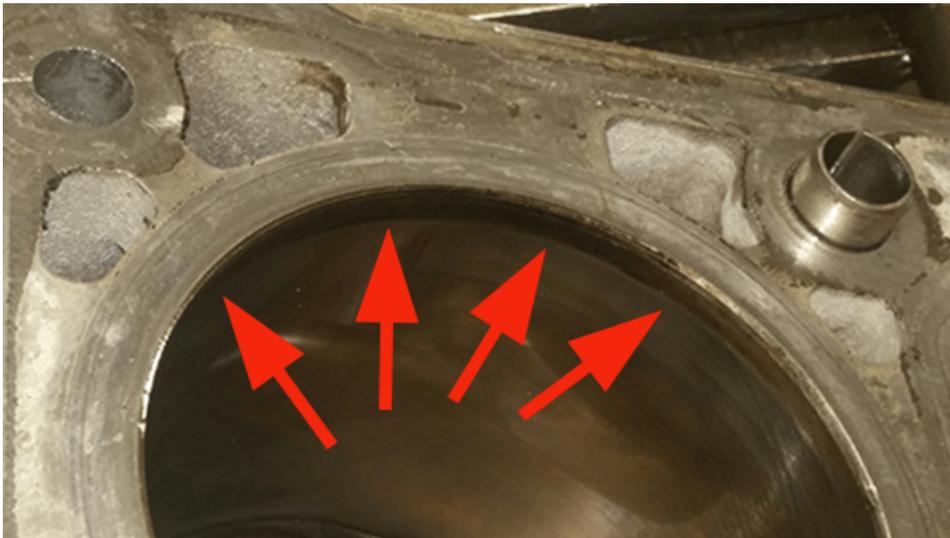
The photo above is an example of what true porosity is.

Location: Could be any cylinder and location at the top of the cylinder.

Cylinder deck face to cylinder liner interface location can cause a leak path into the cylinder for rapid large counts of misfires when cold.

Such Porosity is rare, therefore technicians should inspect the subject cylinder and look for a break in the carbon ring.

Usually if porosity is present there will be a break in the carbon ring.

Coolant present in a cylinder cleans the area of entry and can be found by wiping the carbon ring dry with a clean soft towel, exposing the leak path.

Only if true porosity is found would engine replacement become necessary.

Call PQC per the latest version of 02-07-30-029, if required, reference this PI and replace the engine, ONLY in cases where porosity has been found to be the cause.

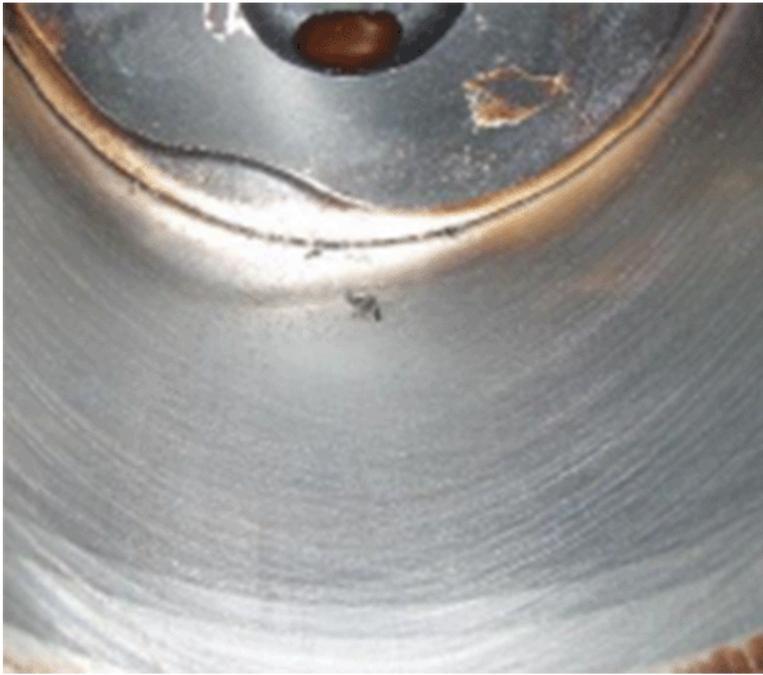
The above picture is a porous pit in the cylinder liner that will cause engine oil consumption.

This also warrants engine replacement.

Call PQC per the latest version of 02-07-30-029, if required, reference this PI and replace the engine, ONLY in cases where porosity has been found to be the cause.
