Bulletin No.: PIC4740F

Service Bulletin

Subject: No Crank - Multiple Warning Telltales On - Trans Shifts Hard

Models: 2006-2011 Cadillac STS Models

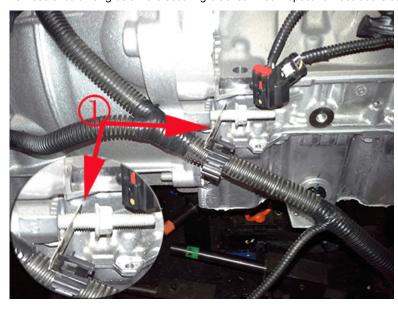
1. Harness Securing Bracket

Inspect the harness securing bracket located on the passenger side of the vehicle where the transmission bell housing is attached to the engine block. The harness should hang below the securing bracket. Also inspect harness at the securing bracket for chaffing.
