Service Bulletin

Subject: SES Light Due to a P0171 - Possibly Due to Unmetered Air

Models: 2006 Buick Rainier
2006 Chevrolet TrailBlazer
2006 GMC Envoy
2006 Saab 9-7x
With 4.2L Engine (VIN S - RPO LL8)

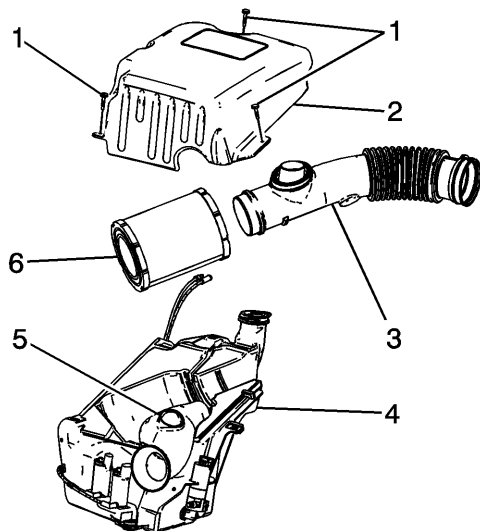
1. Inspect the AIR intake system for rolled connections, cracks, or loose clamps between the MAF sensor and throttle body and repair as necessary.
2. Inspect the screen that is on the inlet side of the air outlet duct for obvious damage. The air outlet duct is #3 in the artwork below.
