# Service Bulletin

## PRELIMINARY INFORMATION

**Subject:** Loud Buzz Or Rattle From Right Front Fender

**Models:** 2007-2008 Cadillac Escalade, ESV, EXT  
2007-2008 Chevrolet Avalanche, Silverado, Suburban, Tahoe  
2007-2008 GMC Sierra, Yukon, Yukon Denali, Yukon XL, Yukon Denali XL

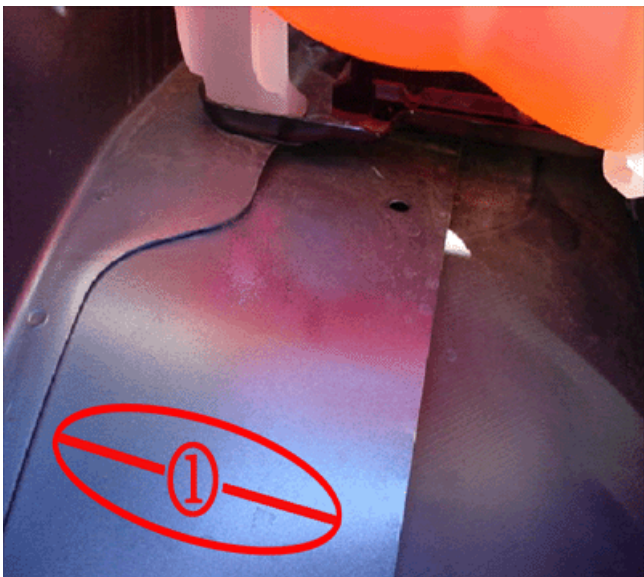
Some customers may comment on a buzz or rattle type noise from the right front fender area on hard acceleration or when brake torquing. The noise is most noticeable at 1800 RPM. The noise can be heard with the radio on and you may think the air intake box is vibrating. This noise may be caused by air turbulence through the fender (from the air cleaner) causing the fender to vibrate. This noise can be isolated by removing the air snorkel (with MAF sensor attached) from the air box and driving or brake torquing the vehicle again.

1. Locate the inner fender flange that is below the coolant bottle by removing the air filter housing (shown below), locate area circled (1) to apply downward pressure on the inner fender flange.
