Service Bulletin

Subject: Intermittent Or No Audio With DTC U0186 or B1325 sym03

Models: 2013-2015 Cadillac ATS Sedan
2015 Cadillac ATS Coupe
2014-2015 Cadillac CTS Sedan (VIN A)

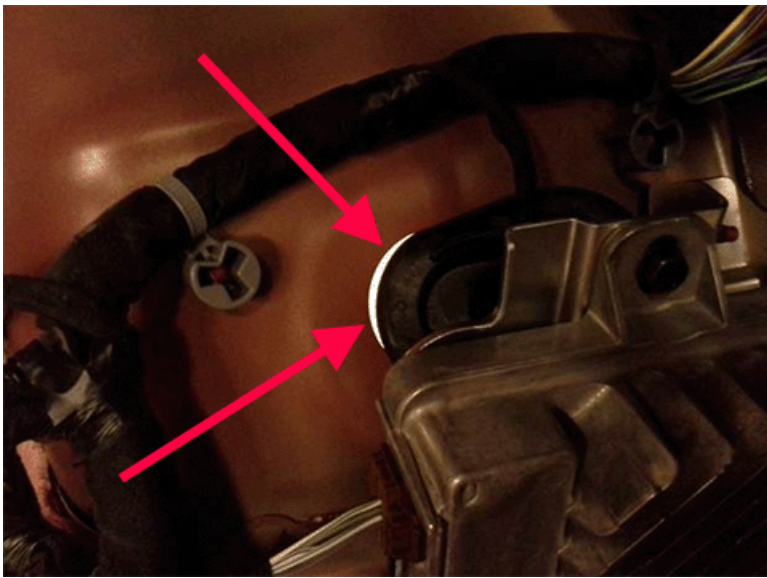
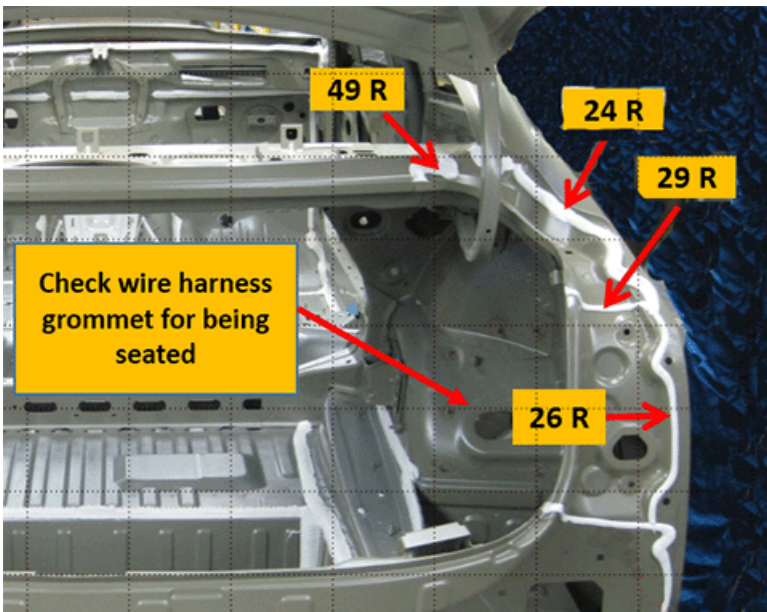
If this is encountered, inspect the trunk area for water intrusion. Amplifiers that have been returned to the WPC (Warranty Parts Center) have evidence of water intrusion causing the amplifier to fail. Water has been known to travel down the harness entering the amplifier through the connector. Repair the area of water intrusion prior to replacing the amplifier to correct this concern. Refer to the diagnostic tips and pictures below.

- Water test the body seams 24R and 49R (see attached picture) starting at the tail lamps working your way up to the back glass. If water intrusion appears to be in one of the body seams apply soap/water mixture to the seam and apply low pressure shop air (20 PSI or less to avoid damaging the seal) and look for signs of air leakage/bubbles. Repair the body seam as required
